## City Of Winchester Public Utilities Visual Inspection Report

### Tank Information for Customer # 8160

- **Tank Name:** Jefferson Street Tank
- **Tank Size/Style:** 3,800,000 Gst
- **Tank Location:** Jefferson Street
- **Project Number:** 101153
- **Service Request:** 359117
- **Inspection Date:** October 25, 2012
- **Report Author:** B\_ETHERIDGE
- **Inspected By:** Larry Palmer

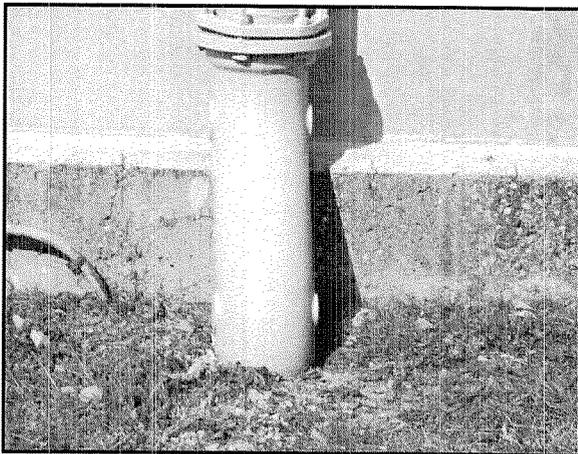
Overflow goes into ground.

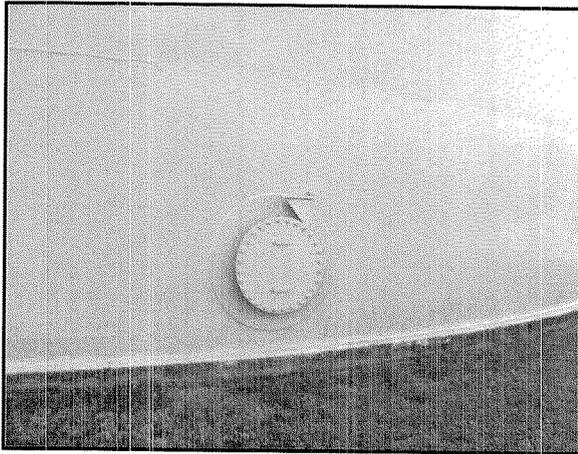
Shell manway is secure.

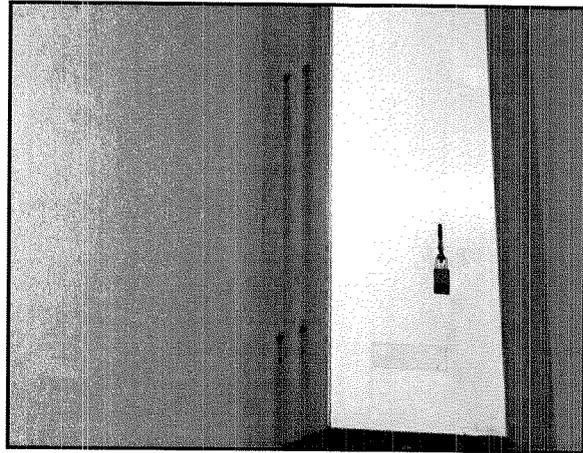
Ladder gate is secured.
