City Of Winchester Public Utilities Washout Inspection Report

- **Tank Name:** Jefferson Street Tower
- **Tank Size/Style:** 300,000 Elevated
- **Tank Location:** Jefferson Street
- **Project Number:** 100736
- **Service Request:** 359103
- **Inspection Date:** February 19, 2013
- **Report Author:** Chris Palmer
- **Inspected By:** Elisha Tucker

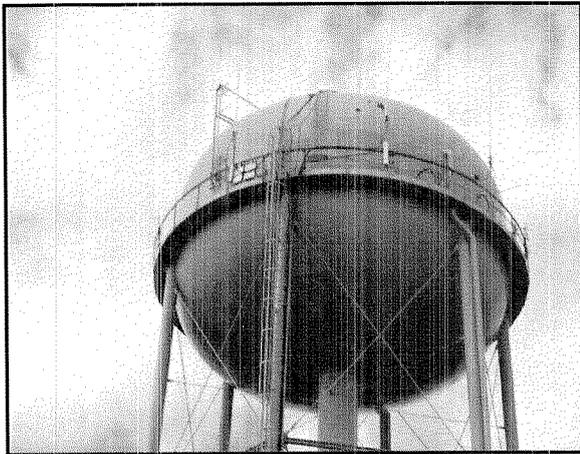
- Interior Coating Condition: The interior coatings were not inspected but will be at the next interior inspection, cleaning and disinfection.
- Exterior Coating Condition: Exterior coating is wearing thin and corrosion is beginning to show. Renovation will be scheduled.

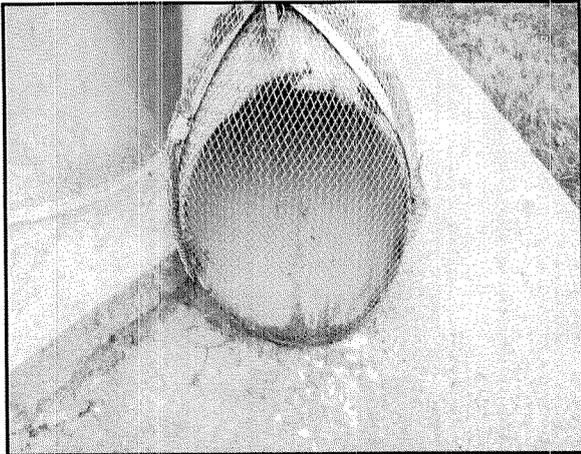
Overflow screen

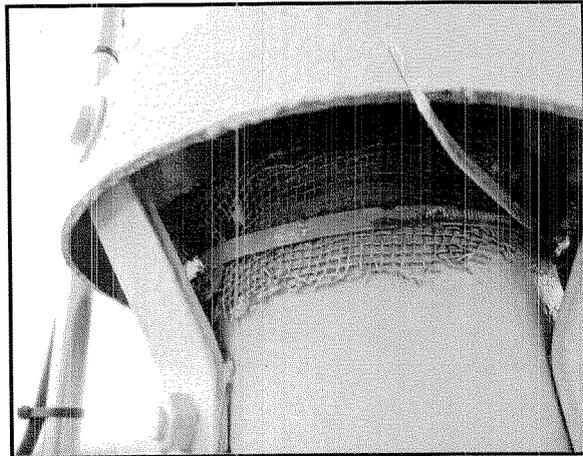
Roof vent screen

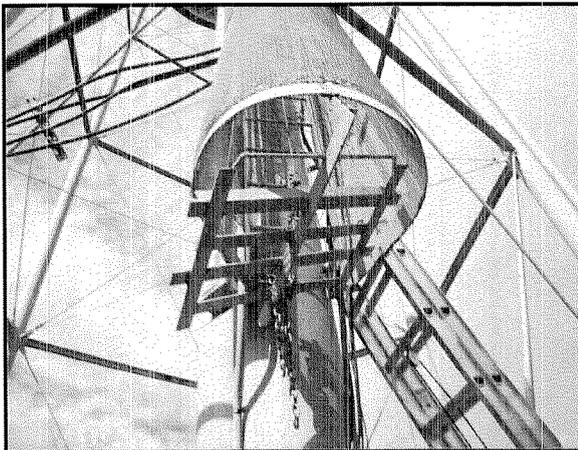
Ladder gate secured

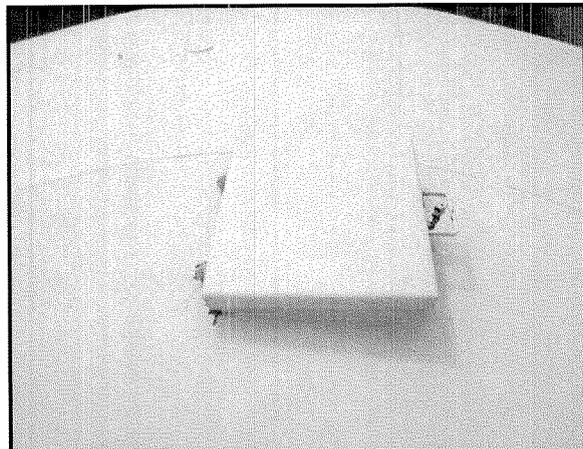
Roof access hatch secured

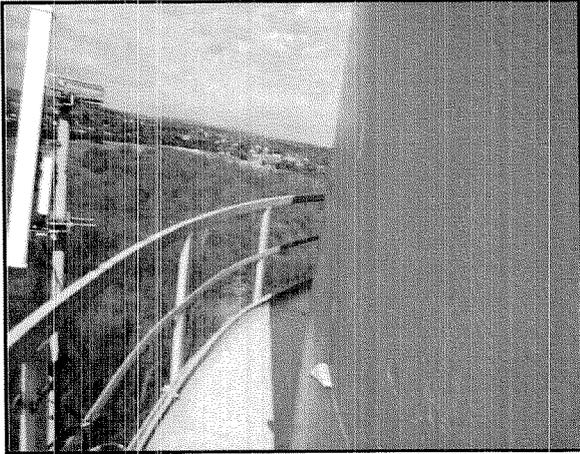
Balcony and handrail

- Watertight Conditions: There are no visible leaks at manway, riser or legs.
- Balcony: Balcony railings and landings are in good condition and free from corrosion damage.

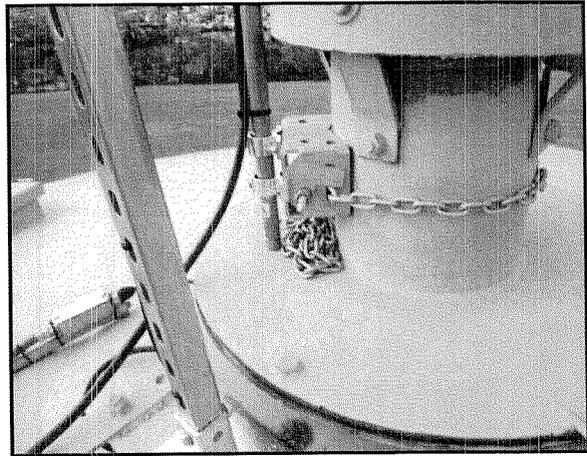
Roof vent

- Interior Ladders: This tank does not have an interior ladder
- Roof: The interior roof does not have roof beams.
- Vents: Vent is in Good Condition.
- Overflow Pipe: Overflow Pipe is in good condition.
