**EVALUATION OF THE
3,000,000 GALLON STEEL GROUND STORAGE TANK**

**“STROTHERS LANE TANK”
WINCHESTER, VIRGINIA**

**HAZEN & SAWYER, P.C.
NEWPORT NEWS, VIRGINIA**

August 15, 2017

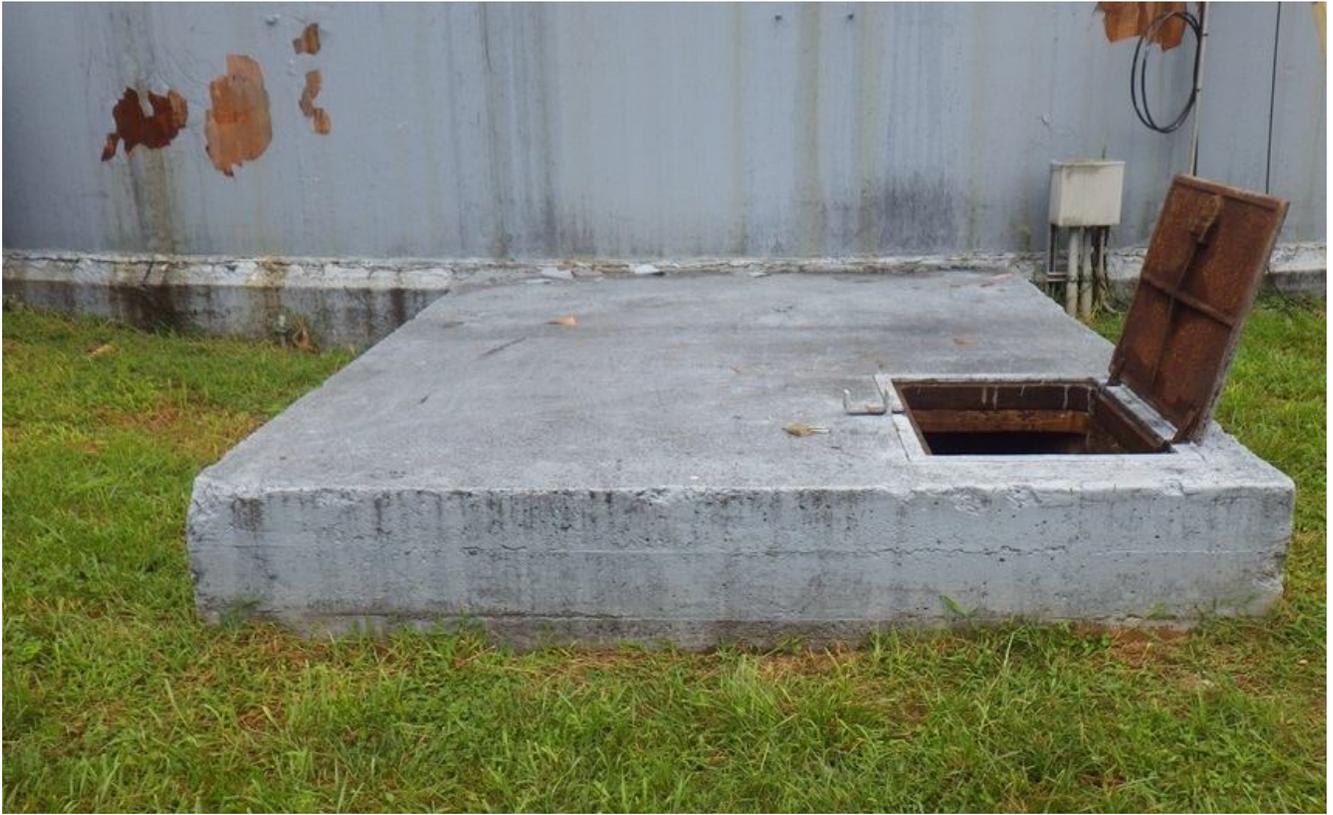
5. Valve vault.

5. **Valve Vault: There were safety and OSHA deficiencies noted: (1) the 8-1/2 in. access rung width did not meet the required 16 in. minimum, (2) the 14-3/4 in. to 15-1/4 in. spacing between access rungs did not comply with the requirement for rungs to be spaced at consistent intervals no more than 14 in. apart, and (3) the 24-1/2 in. head clearance did not meet the minimum required 30 in.** There was a valve vault attached to the south side of the foundation. Access into the valve vault was locked prior to or after this field evaluation. The piping in the valve vault was generally rust covered, with layering corrosion and metal loss on piping nuts and bolts. A drain was located in the vault floor. (See photos 5-10)

5. **Valve Vault:** The access rungs should be replaced with rungs which meet current requirements. The piping and valves located in the valve vault should be cleaned and painted in accordance with the interior coating recommendations at the time of the tank cleaning and coating. The exterior concrete surfaces should be cleaned to the equivalent of a brush-off blast cleaning and painted with a concrete sealer. The valve vault access should continue to be locked at all times in order to limit liability to the Owner and to protect water system security. Freeze protection should be provided for on all control piping and static water lines. Specifications should be written to anticipate the replacement of the piping nuts and bolts.

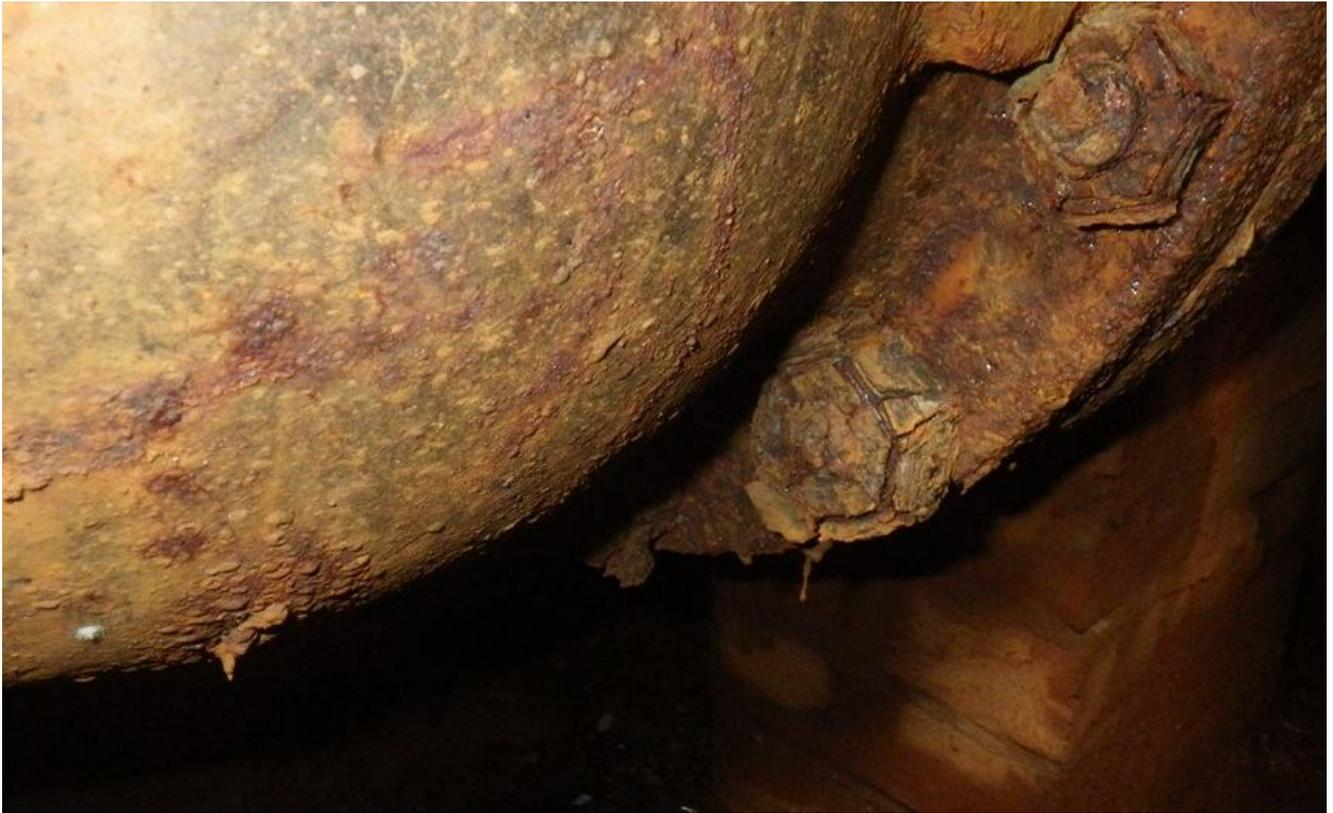
9. Valve vault piping bolts and nuts. Note significant layering corrosion.

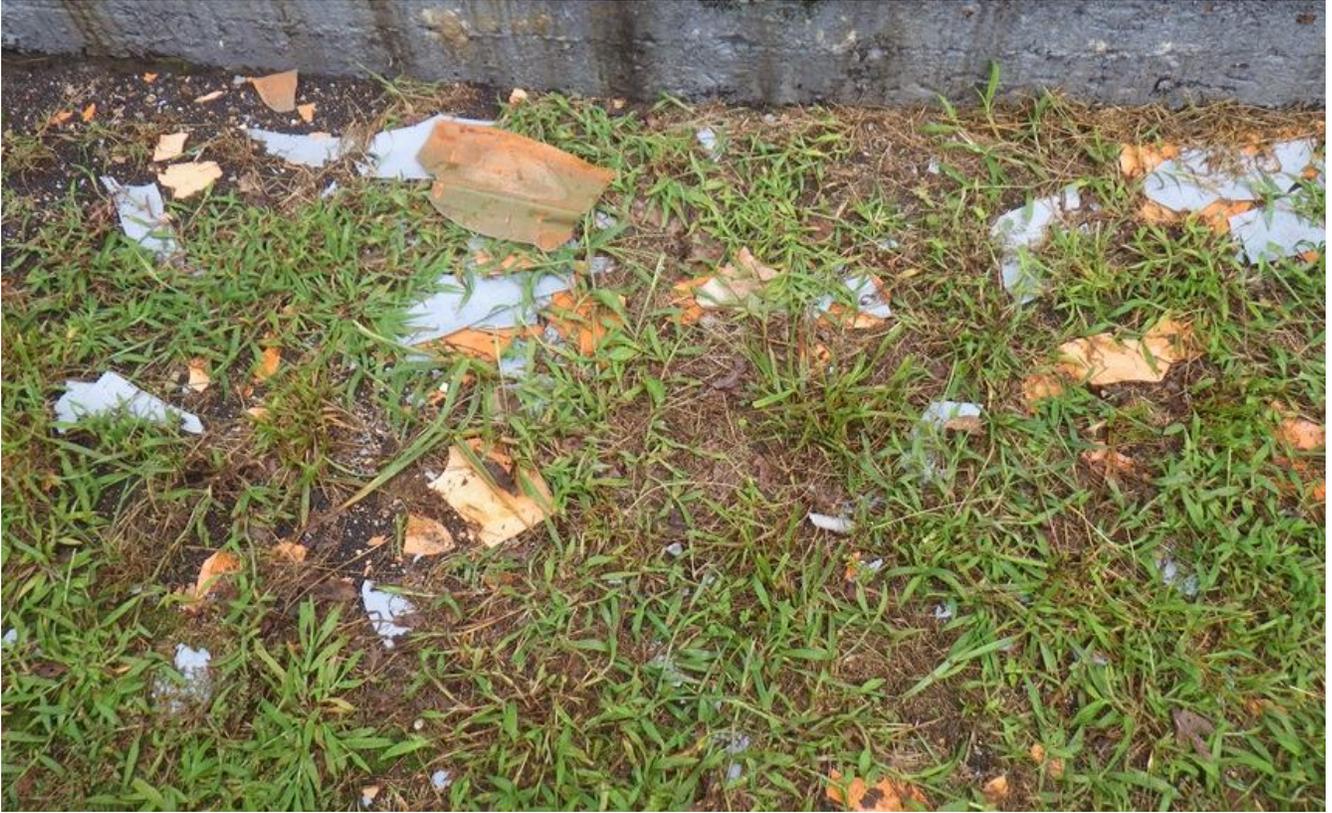
2. **Site Conditions:** The tank site was covered with grass and was graded to provide adequate drainage away from the foundation. The tank site was not fenced. What appeared to be blast media was found on the ground surrounding the tank. Tree limbs were growing in close proximity to the tank. A hydrant was located on the south part of the site. Failed coating chips were located on the ground around the tank. (See photos 1, 11)

11. Pieces of peeled coating on ground.

1. **Site Maintenance:** The site should be maintained so that the top of the foundation projects a minimum of 6 in. to a maximum of 12 in. above grade and so that proper drainage away from the foundation continues. Site maintenance should be performed with the mower discharge directed away from the base of the tank to prevent rock chips in the coating and the accumulation of grass on the bottom plate. A fence should be installed and the gate should be locked at all times to deter unauthorized entry and limit liability for the Owner. The surrounding tree branches should be regularly trimmed so they do not come into close proximity with the tank. The failed coating pieces should be removed from the site as soon as possible.

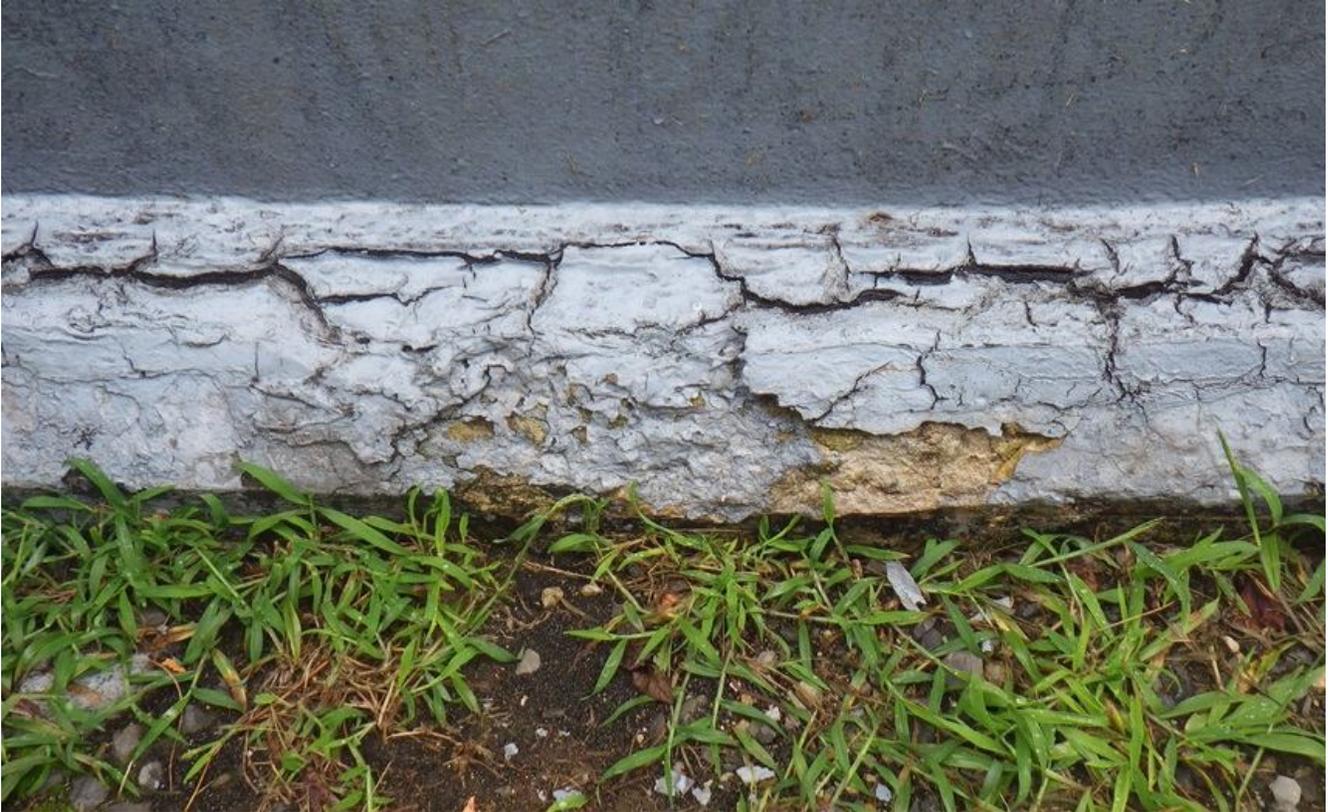
3. **Foundation:** The tank foundation appeared to be a concrete ringwall. Much of the foundation was covered with sealant limiting the surfaces which could be viewed. Cracking, spalling, erosion, and small surficial holes were observed in the concrete foundation at the time of this field evaluation. The foundation sounded hollow when struck. The foundation exhibited the AWWA recommended 6 in. to 12 in. projection above grade, and exceeded it in other areas. Coating was visible on the exposed concrete surfaces at the time of this field evaluation. (See photos 12-14, 16)

12. Cracking and spalling in foundation.

3. **Foundation:** When the tank exterior is repainted, any unsound concrete should be chipped to sound material and the concrete should be brush-off blasted. Any deteriorated areas or voids found should have a bonding agent and a vinyl emollient modified concrete patching mortar applied to build up the surface to its original contour. The concrete should then be painted with a concrete sealer.

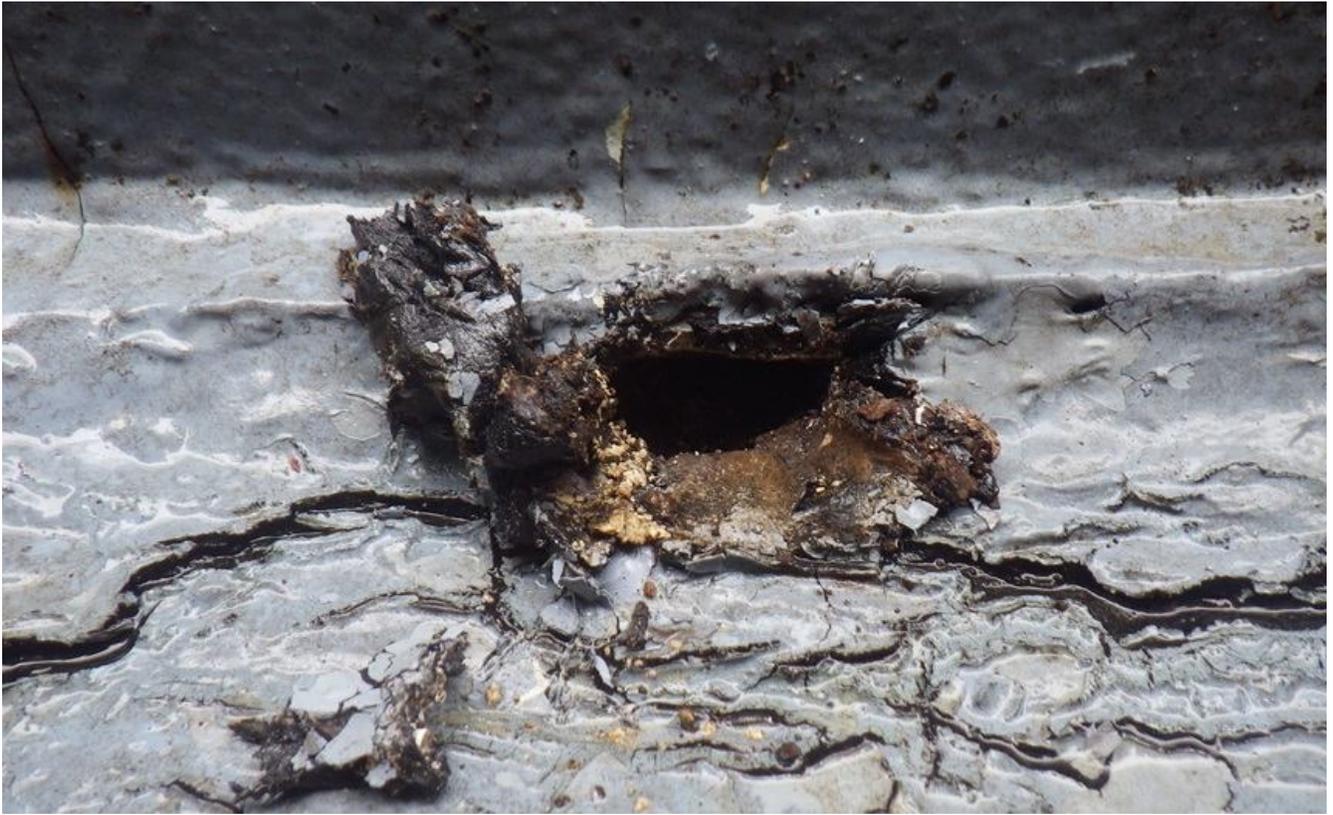
4. **Sealant:** There was a thick bituminous-based sealant located around the bottom plate and foundation which was in poor condition. Cracking was observed in numerous areas, and gaps measuring up to 1 in. wide were present in the sealant. The sealant prevented visibility of the bottom plate-to-foundation interface. (See photos 13-14)

13. Foundation and bottom plate at void in sealant.

4. **Sealant Maintenance:** When the exterior repainting is performed, the existing sealant located between the bottom plate and the foundation should be removed and replaced with a flexible polyurethane sealant.

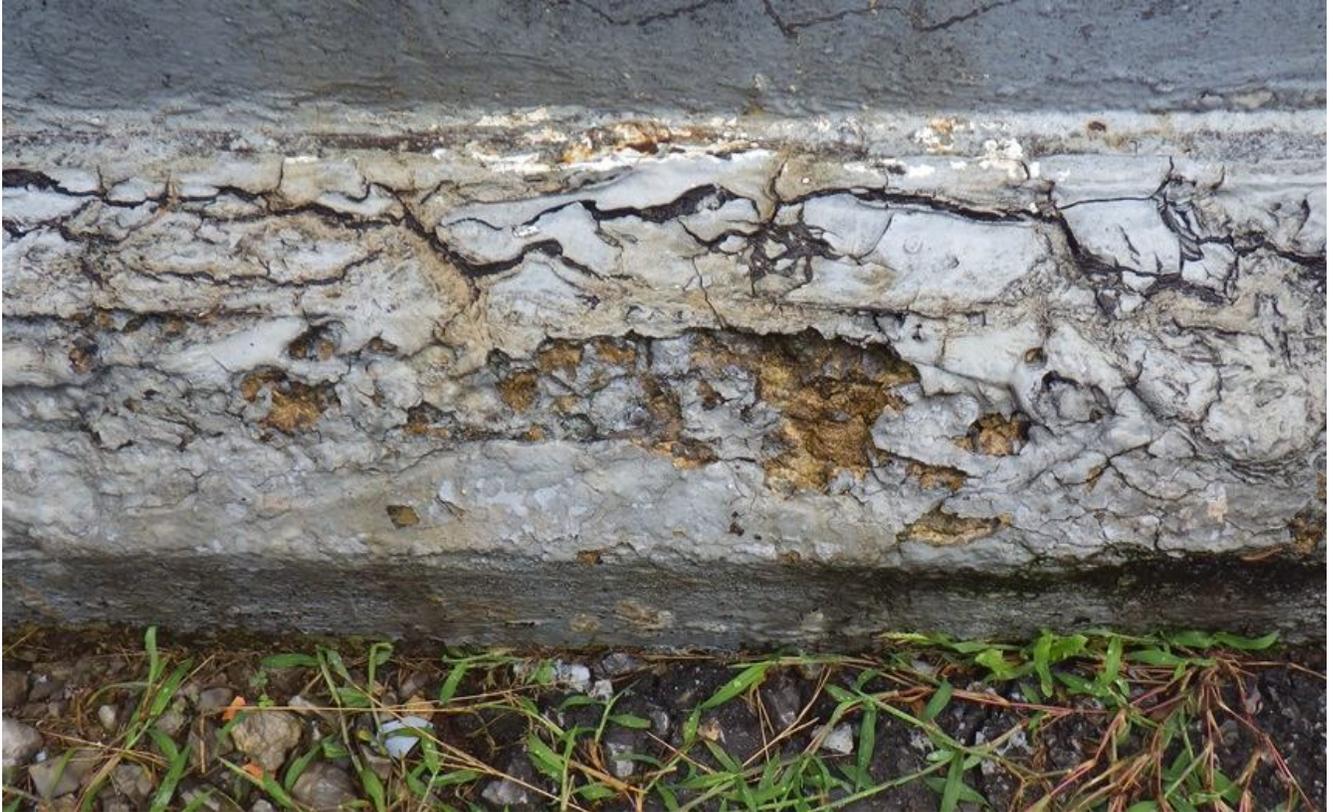
14. Peeled sealant on foundation.

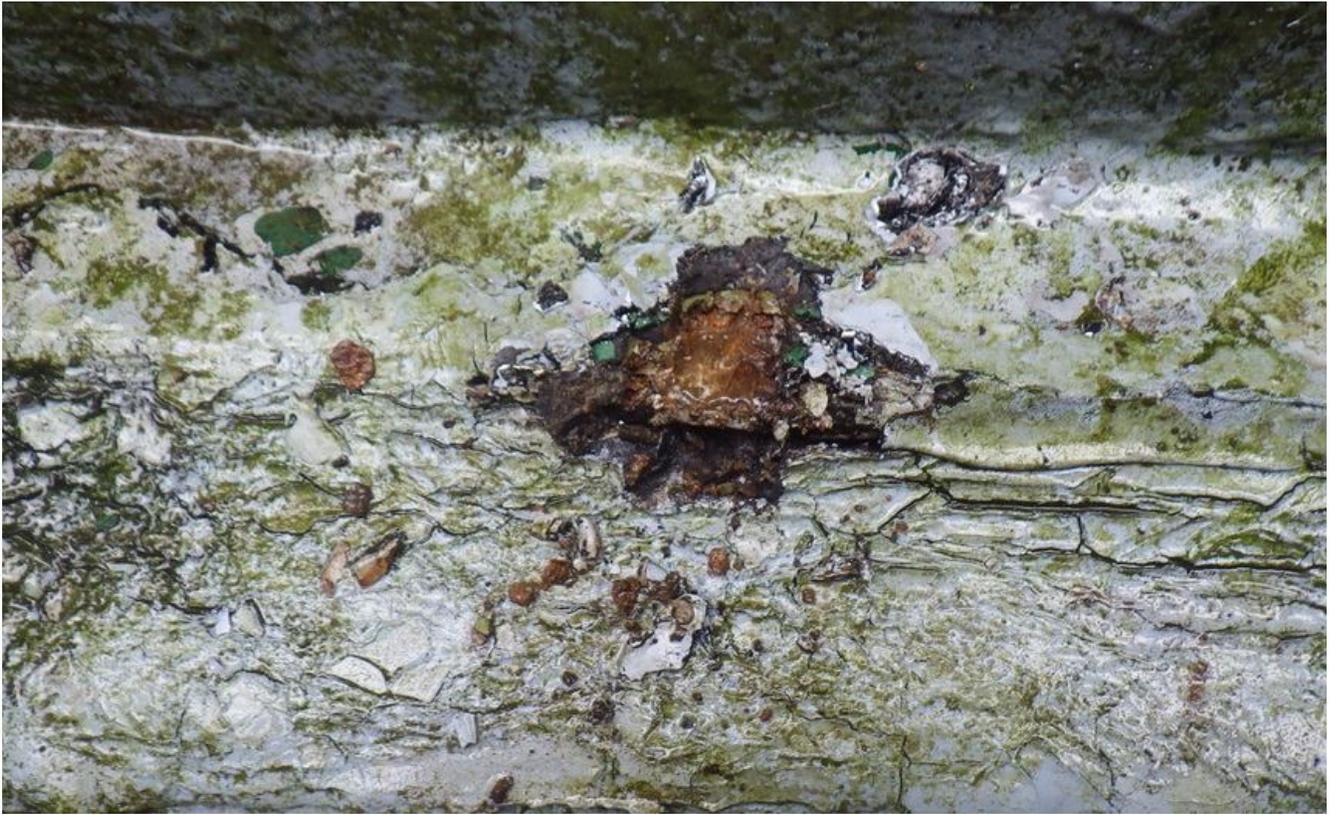
2. **Bottom Plate:** Most of the bottom plate exterior projection was obscured by the presence of sealant. Corrosion and peeled coating were located on the visible surfaces. (See photos 13, 15)

15. Corrosion on bottom plate.

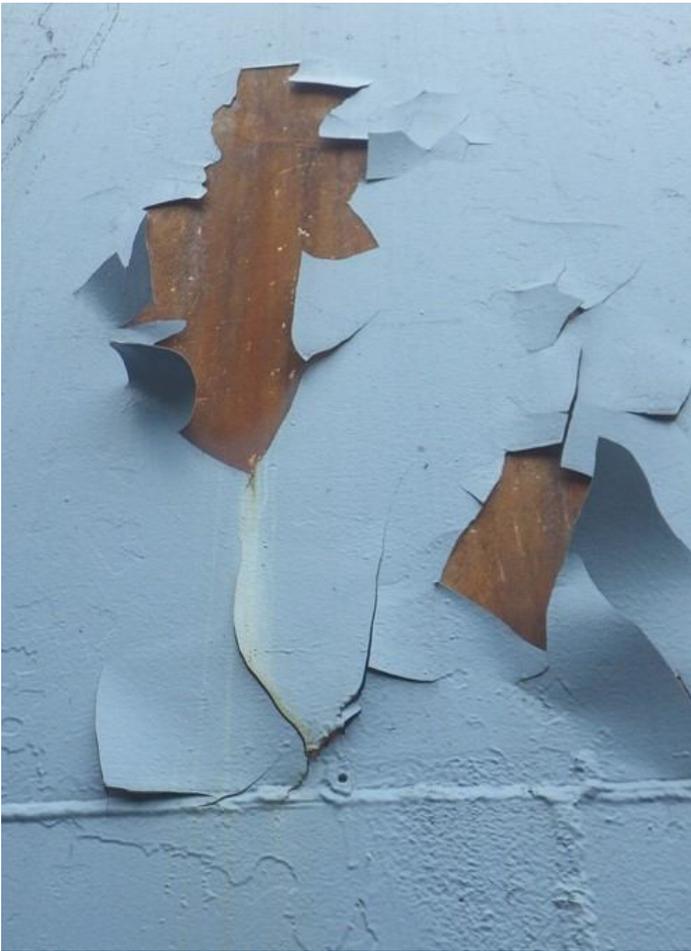
3. **Shell Condition: There was a structural deficiency noted: a welded steel door sheet in the shell did not contain rounded corners.** The contour of the tank shell was generally poor with widespread banding and flat areas observed. The coating appeared to be in poor overall condition with large areas of peeled coating and corrosion. The coating exhibited very poor adhesion to the steel.

19. Coating failure on exterior shell.

1. **Life of the Exterior Coating:** The exterior coating system appeared to be in very poor condition and not providing adequate corrosion protection to the steel surfaces. Tank Industry Consultants believes that the exterior of the tank should be repainted within the next 2 to 3 years from a corrosion standpoint or sooner if aesthetics are of concern. Due to the very poor adhesion of the existing exterior coating and extent of coating failure noted, topcoating is not recommended.

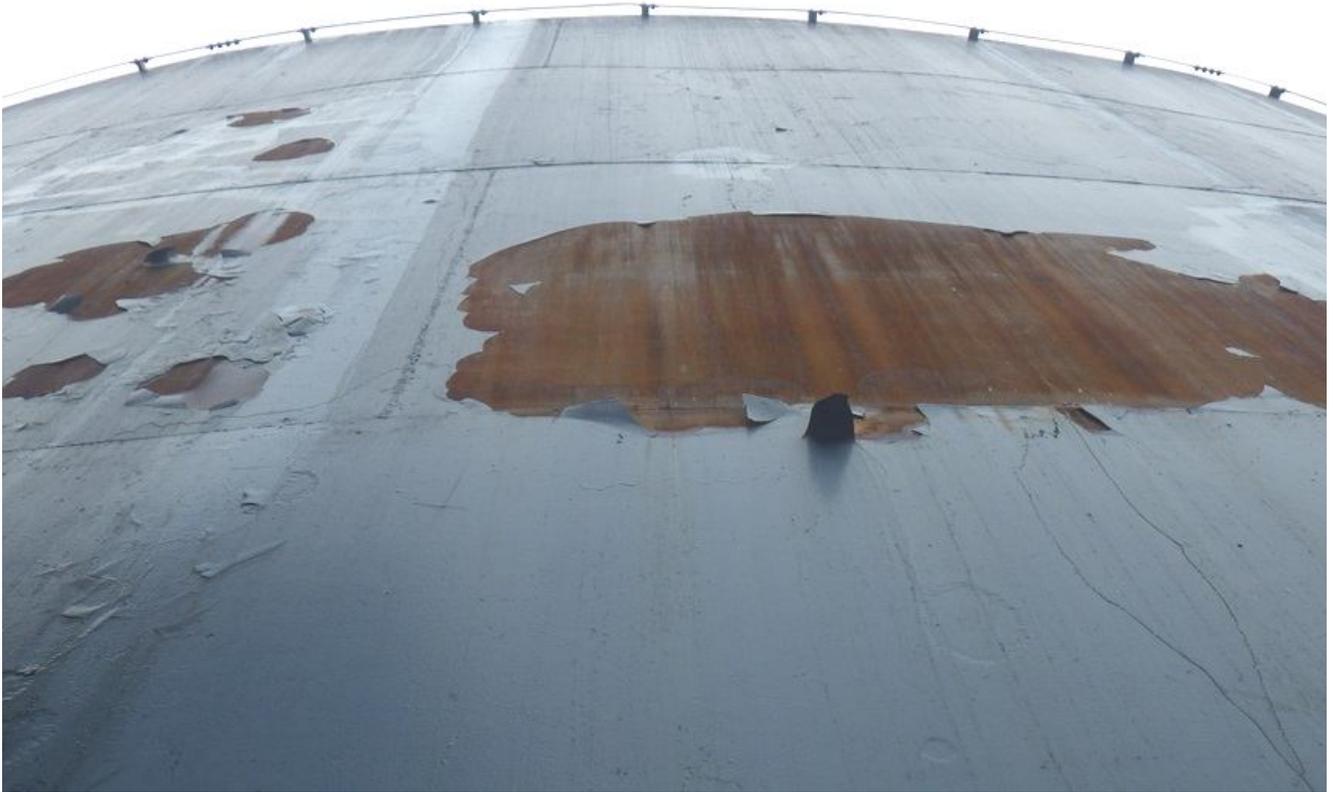
21. Peeled coating and corrosion on shell.

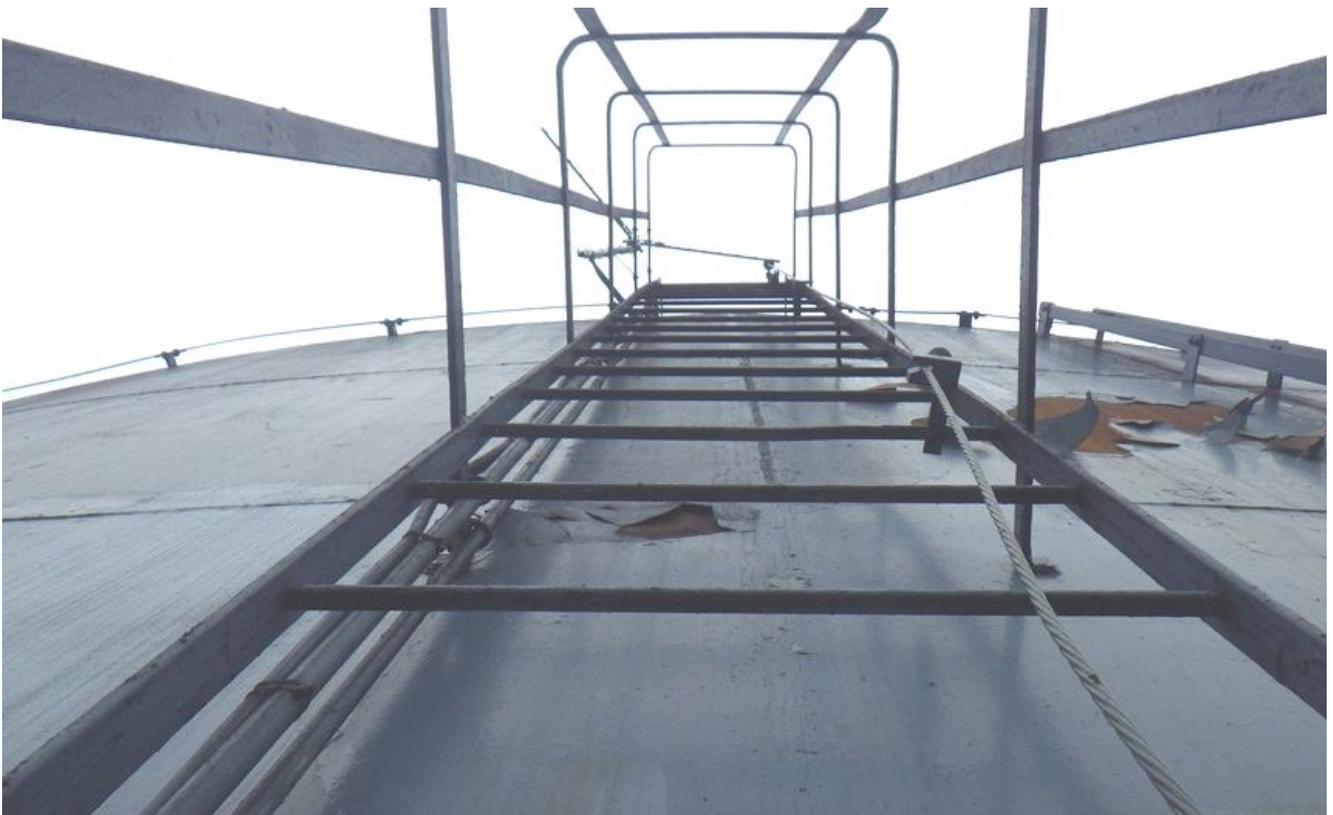
6. **Exterior Shell Ladder:** There were safety and ANSI/OSHA deficiencies noted: (1) **the paint on the safe-climbing device may not allow the device to function properly,** (2) **the offset design of the safe-climbing device may prevent its proper operation,** (3) **the 2 in. x 3/8 in. side rails did not meet the required minimum of 2-1/2 in. x 3/8 in. side rails,** (4) **the vandal deterrent was not equipped with side panels to prevent unauthorized access up the back of the exterior ladder,** (5) **the ladder rungs were not spaced at intervals no more than 14 in. apart,** (6) **conduits were attached to the ladder brackets which could interfere with the unrestricted use of the side rails by the climber,** (7) **the 13-1/2 in. spacing between vertical bars on the safety cage exceeded the maximum allowed 9-1/2 in., and** (8) **the base of the safety cage was not flared.** A ladder provided access from a height of approximately 13 ft from the ground to the roof. The ladder was equipped with a cable-type safe-climbing device, but the device had been painted and was installed such that it may not operate properly. The exterior ladder was welded to brackets which were welded to the shell. The exterior ladder and brackets appeared to be in nearly their original structural condition at the time of this field evaluation. The ladder was equipped with a safety cage which was constructed of welded flat bar members. The base of the ladder was equipped with a swinging gate vandal deterrent. Terminals were located at the ladder access to the roof. An antenna was attached to the top of the ladder safety cage. (See photos 31-32, 36)

32. Exterior shell ladder, safety cage, and safe-climbing device. Note offset safe-climbing device.

16. **Exterior Ladder:** The exterior ladder should be replaced with a ladder which meets current requirements. In addition, the safety cage is not required on ladders with safe-climbing devices. To reduce cleaning and painting costs and future maintenance costs, because the existing safety cage is not OSHA compliant, and because OSHA is phasing out the use of the safety cages in lieu of the installation of safe-climbing devices, the cage could be removed and the existing painted and improperly installed safe-climbing device replaced. The conduits should be relocated away from the side rails. The exterior ladder did not include slip-resistant rungs. Slip-resistant rungs are required for all ladders constructed after March 1991 by the OSHA Construction standards. However, slip-resistant rungs are not required by the OSHA General Industry standards for ladders or by AWWA D100. When the roof safety railing is installed, the ladder terminals should be removed.

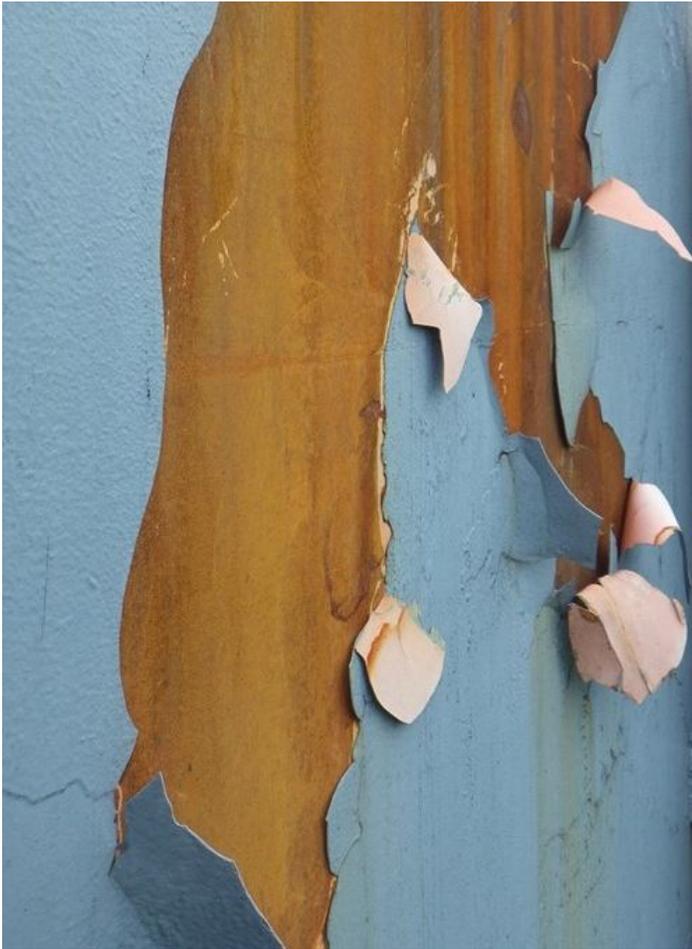
35. Coating failure on exterior shell.

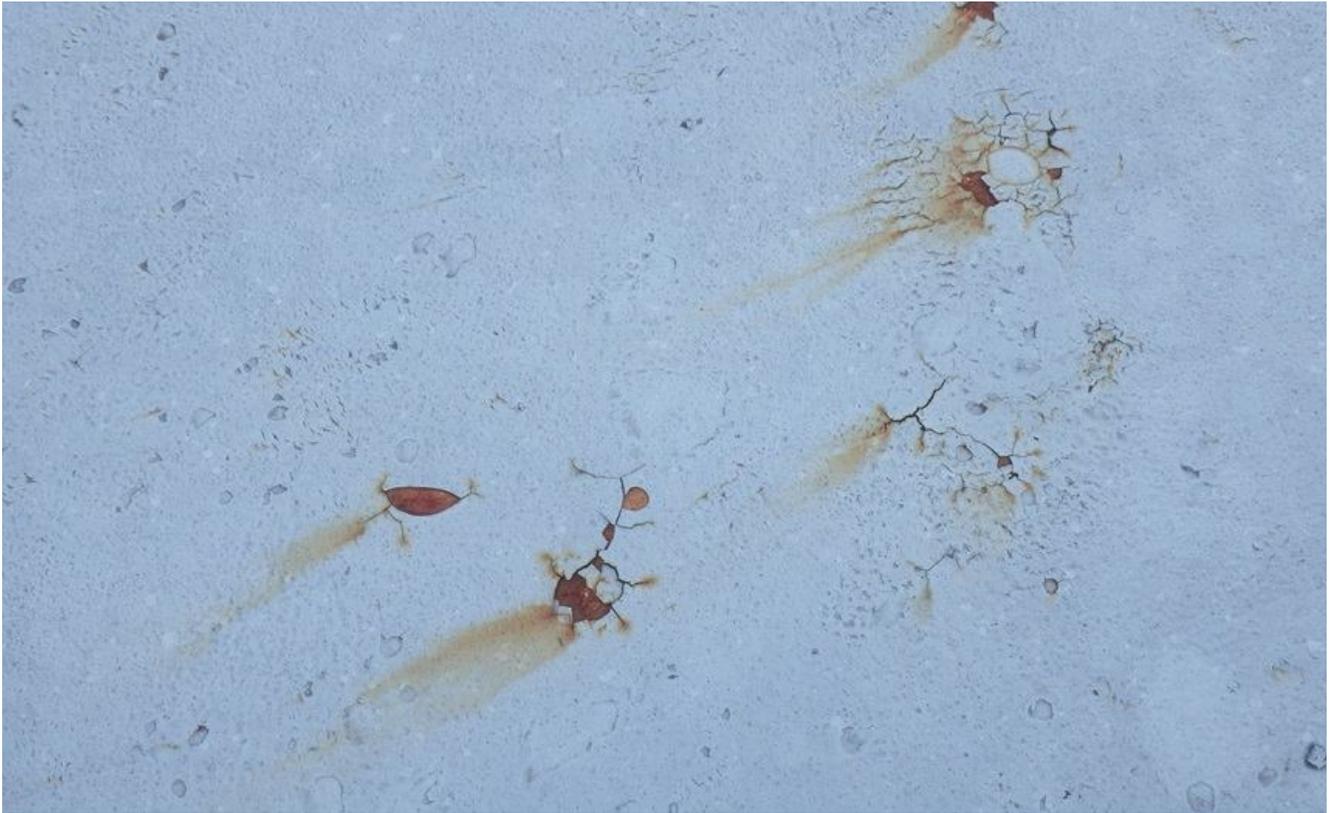
8. **Roof Condition.** The contour of the roof was irregular with evidence of trapped water noted. The roof coating was in poor condition with widespread areas of cracked and peeled coating and corrosion noted. The coating had chalked and checked, and debris and drips were observed in the coating. The coating on the roof exhibited very poor adhesion to the steel. A solar panel and cabinet

37. Exterior roof coating failures.

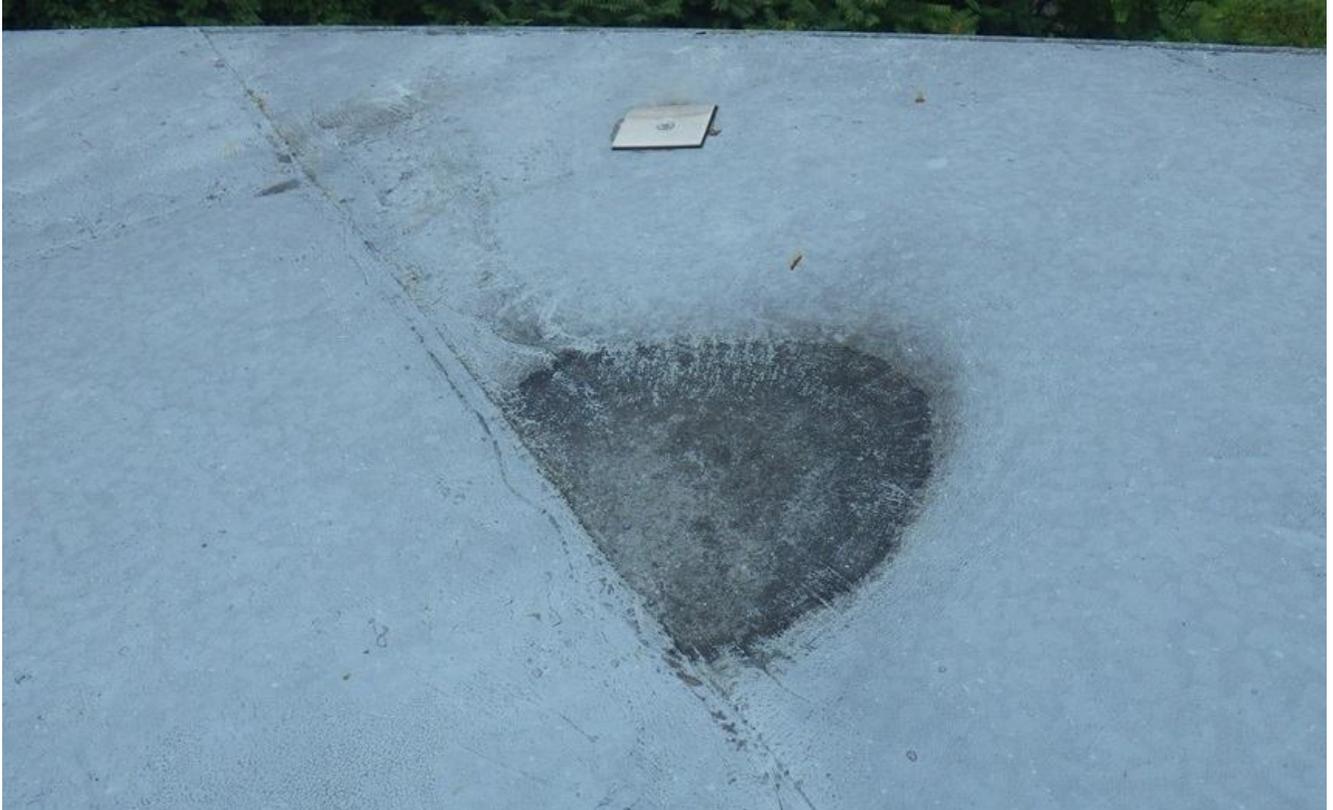
38. Evidence of water ponding on roof.

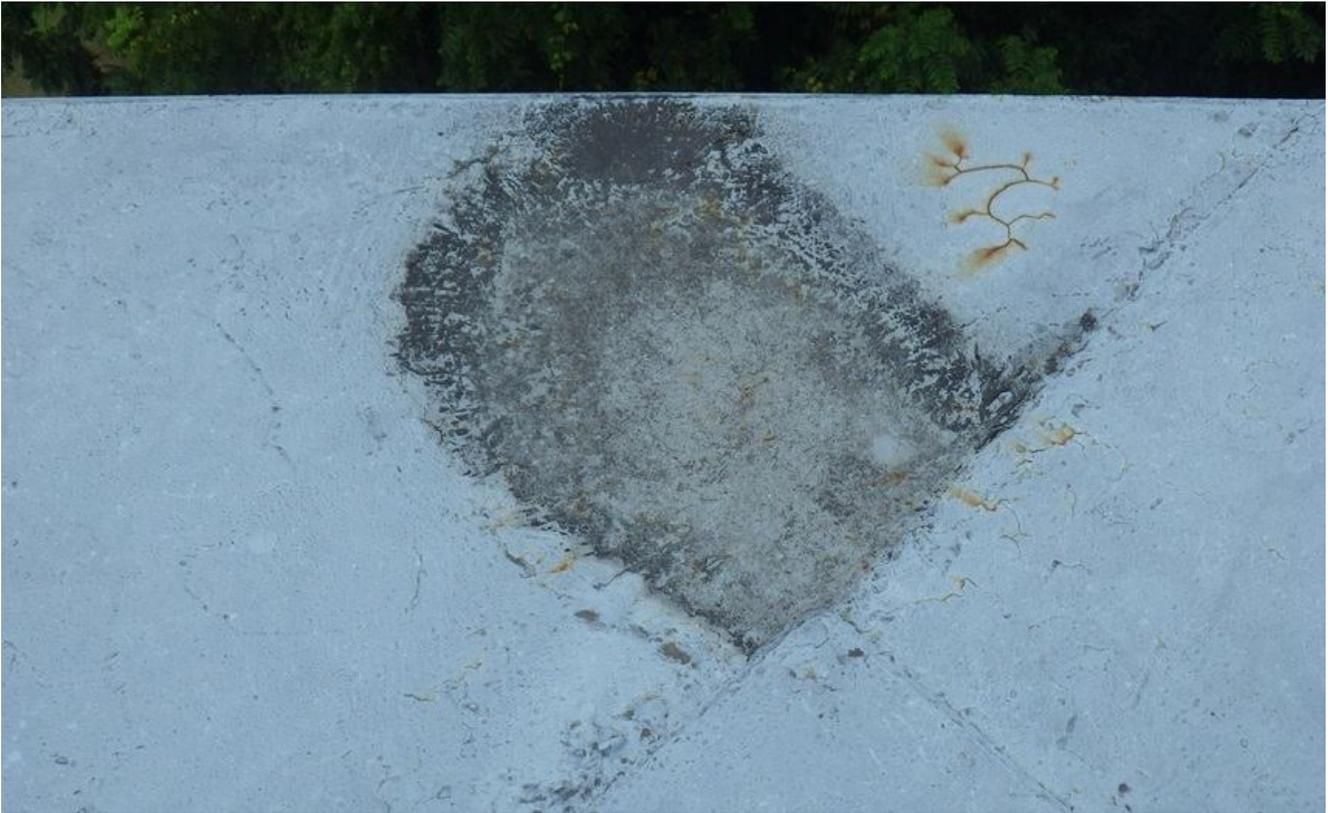
39. Evidence of water ponding on roof.

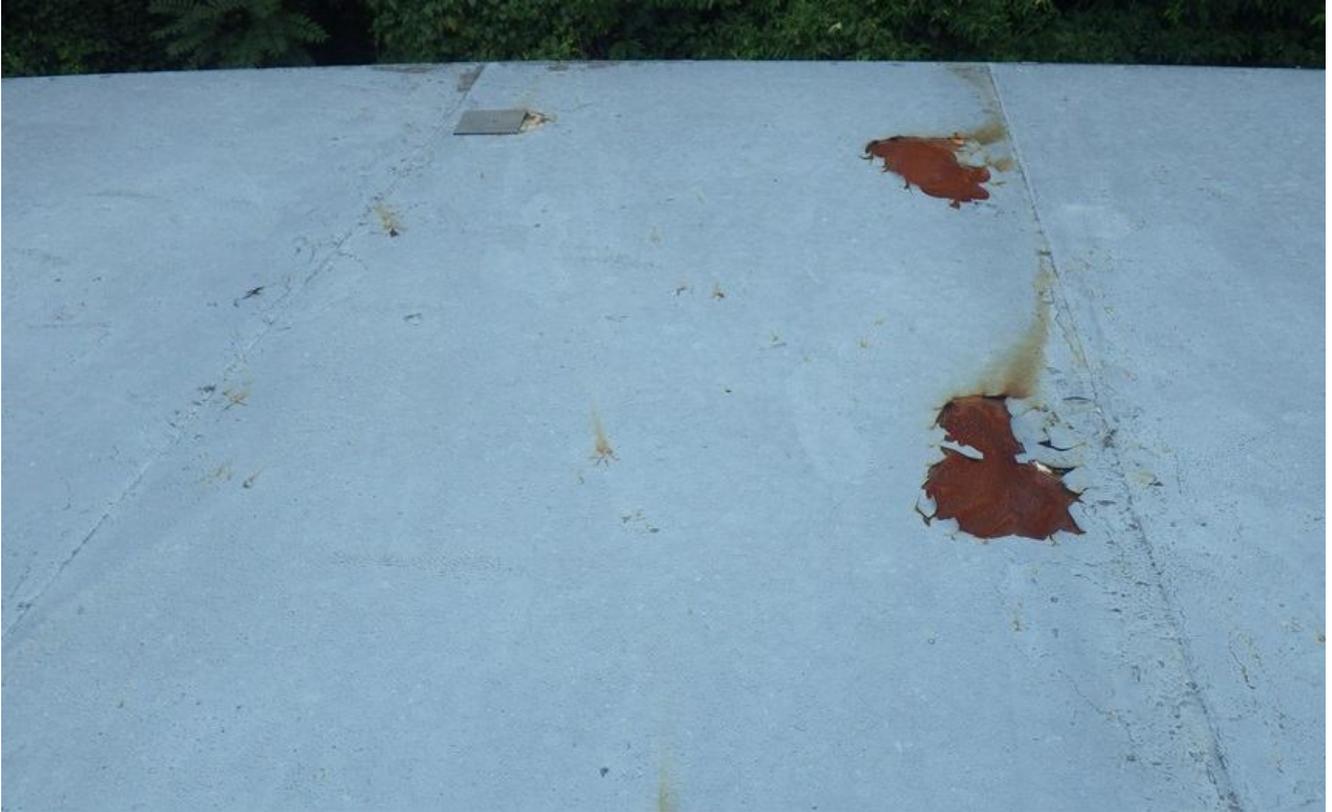
40. Exterior roof coating failures.

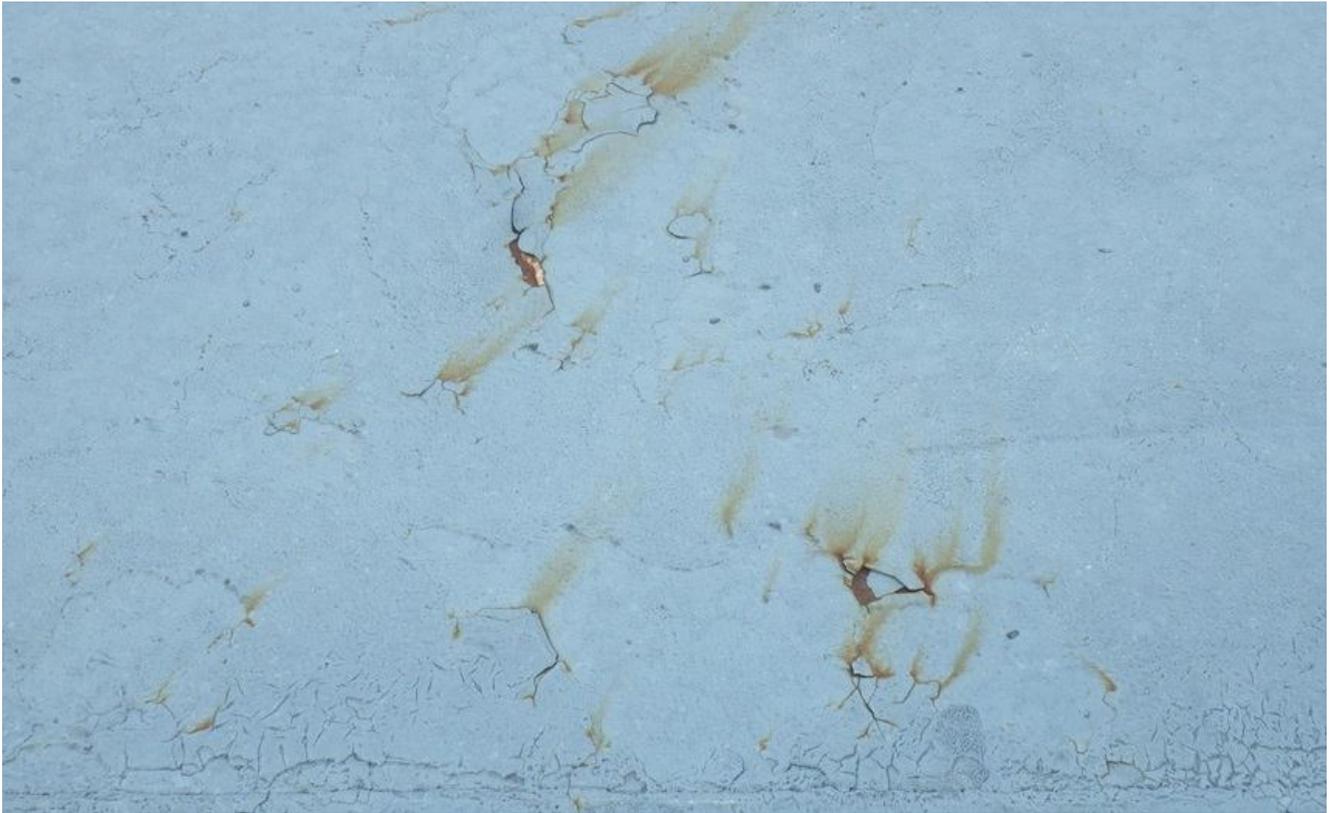
41. Exterior roof coating failures.

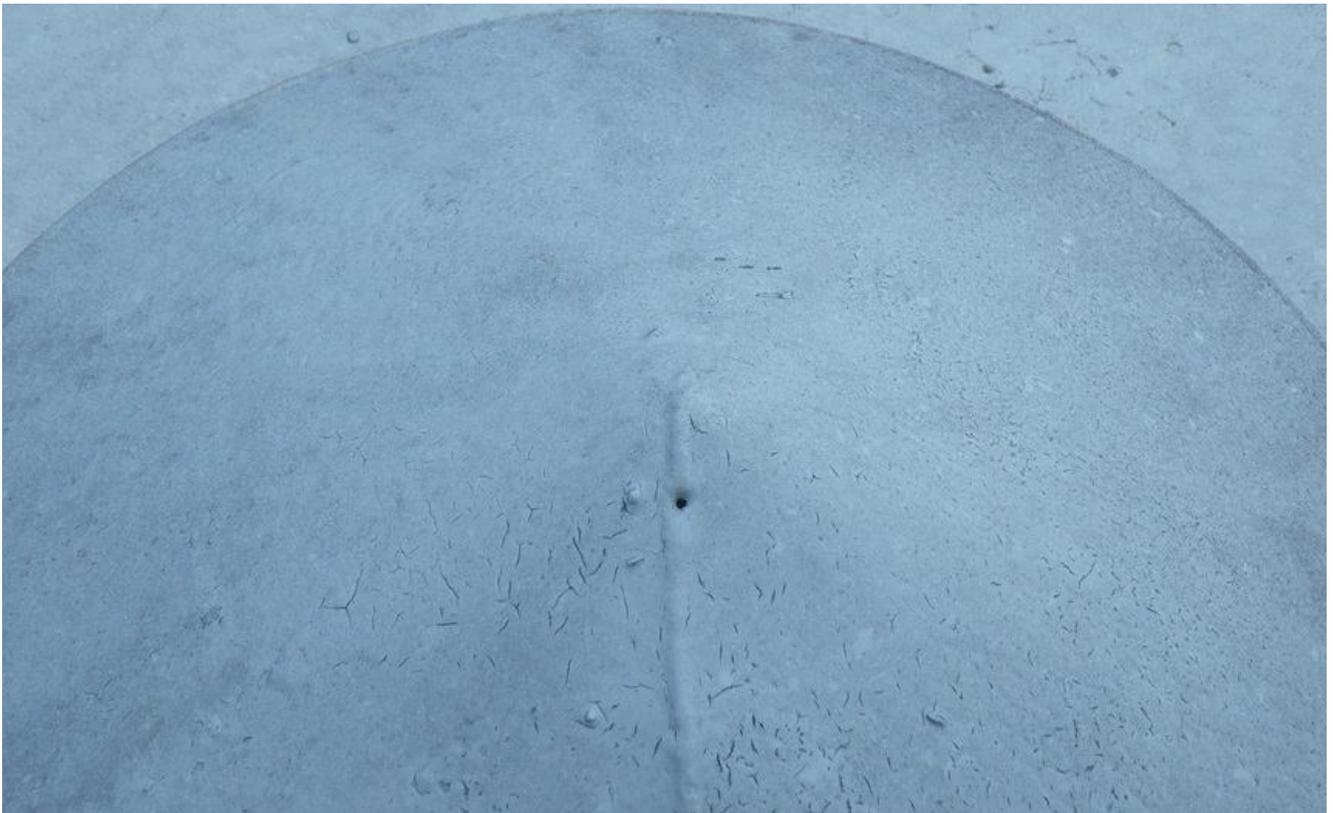
10. **Roof Vents:** There were sanitary and operational deficiencies noted: **(1) the roof vents were not of a clog-resistant design, (2) gaps between the center vent screening and cover could allow the ingress of insects into the tank, (3) a hole was located in the cover of one of the vents which could allow the ingress of insects and runoff water into the tank, (4) the conical cover vents were not equipped with gaskets, (5) the screening on none of the vents was shielded from wind-driven dust and debris, and (6) the size of the screening on the conical cover vents was not adequate to prevent the ingress of insects into the tank.** The roof was equipped with three vents such that the center one had a mushroom cover and the other two had conical covers. The conical cover vents were attached to flanged openings. The flanges were not equipped with gaskets. The size of the screening on the conical cover vents could allow the ingress of insects into the tank. The center vent was equipped with a layer of fine mesh screening and expanded metal. However, gaps at the center vent screening could allow the ingress of insects. The vertically oriented screening on each of the vents was not completely shielded from wind-driven dust and debris. (See photos 45-46, 49)

46. Hole in roof vent cover.

19. **Clog-Resistant Vents:** The tank was not equipped with clog-resistant vents. AWWA Standards recommend that all vents with screening against insects be designed to ensure "fail-safe" operation if the insect screens become occluded. Inadequate ventilation could cause a tank collapse if the tank is rapidly drained while the screen is occluded or frosted over. Therefore, clog-resistant vents should be installed. The existing center vent opening should be equipped with a large flanged opening for evaluating, cleaning, repairing, and painting the interior roof structure ends at the center. Until such time as the new vents can be installed, the hole in one of the conical vent covers should be sealed. The flanges on the conical cover vents should be equipped with gaskets, and the conical cover vent screening replaced with more restrictive screening. The gaps in the center vent screening should be eliminated. The conical cover vents should be equipped with vertical shields.

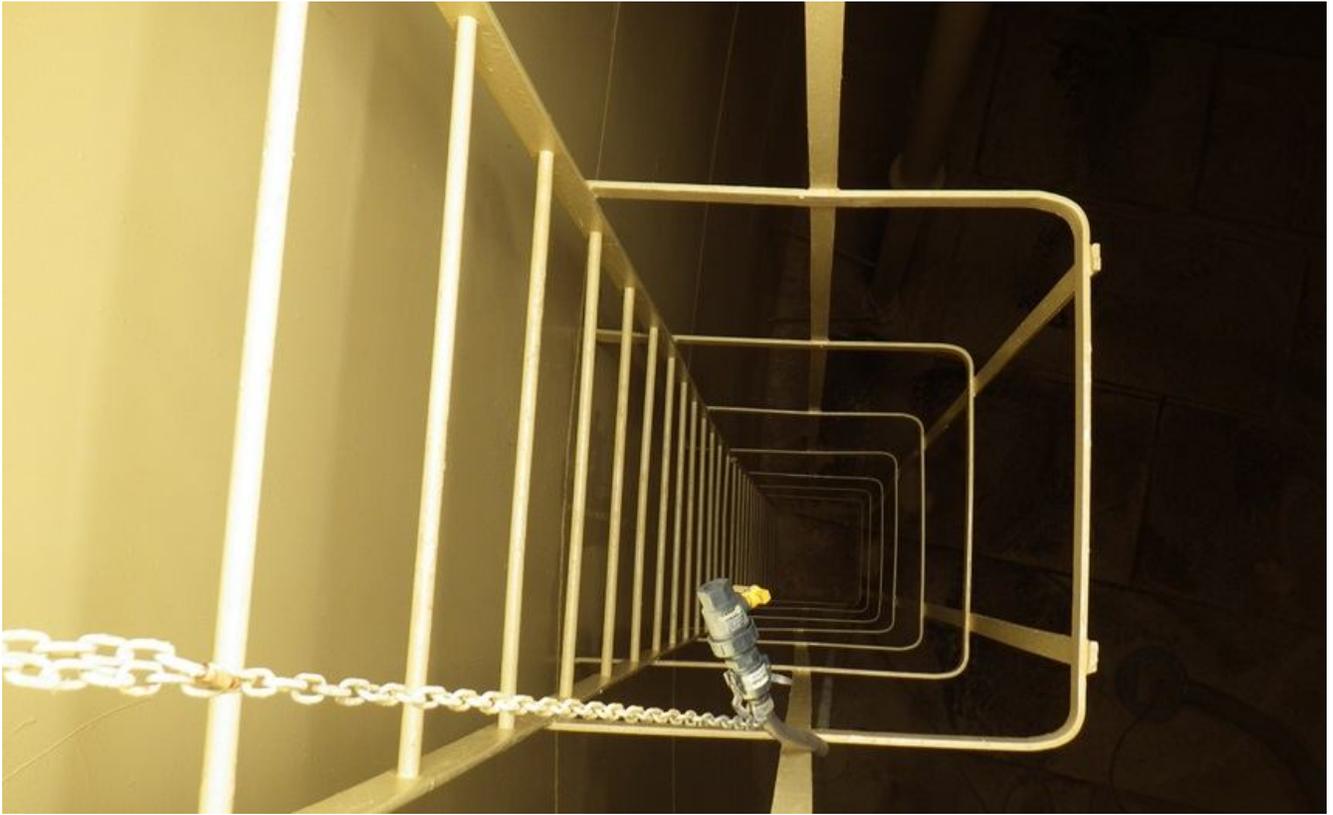
53. Interior ladder.

5. **Interior Ladder: There were safety and ANSI/OSHA deficiencies noted: (1) the 2 in. x 3/8 in. ladder side rails did not meet the required minimum of 2-1/2 in. x 3/8 in. side rails, (2) the 14-3/4 in. ladder rung spacing exceeded the maximum allowed 14 in., (3) the 28-1/4 in. depth of the ladder safety cage exceeded the OSHA required 27 in. to 28 in., and (4) the 14-1/2 in. spacing between vertical bars on the safety cage exceeded the maximum allowed 9-1/2 in.** A ladder provided access from the roof manhole to the floor. The ladder was not equipped with a safe-climbing device but was equipped with a safety cage constructed of flat bar members. The interior ladder was welded to brackets which were welded to the shell. The interior ladder and brackets appeared to be in nearly their original structural condition at the time of this field evaluation. (See photos 52-53, 71)

7. **Interior Ladder:** Interior ladders may be susceptible to ice damage and accelerated rates of corrosion. If the Owner decides to keep the interior ladder, the ladder should be replaced by a ladder which complies with current industry standards and should be equipped with a corrosion-resistant safe-climbing device.
