**EVALUATION OF THE
3,000,000 GALLON STEEL GROUND STORAGE TANK**

**“STROTHERS LANE TANK”
WINCHESTER, VIRGINIA**

**HAZEN & SAWYER, P.C.
NEWPORT NEWS, VIRGINIA**

August 15, 2017

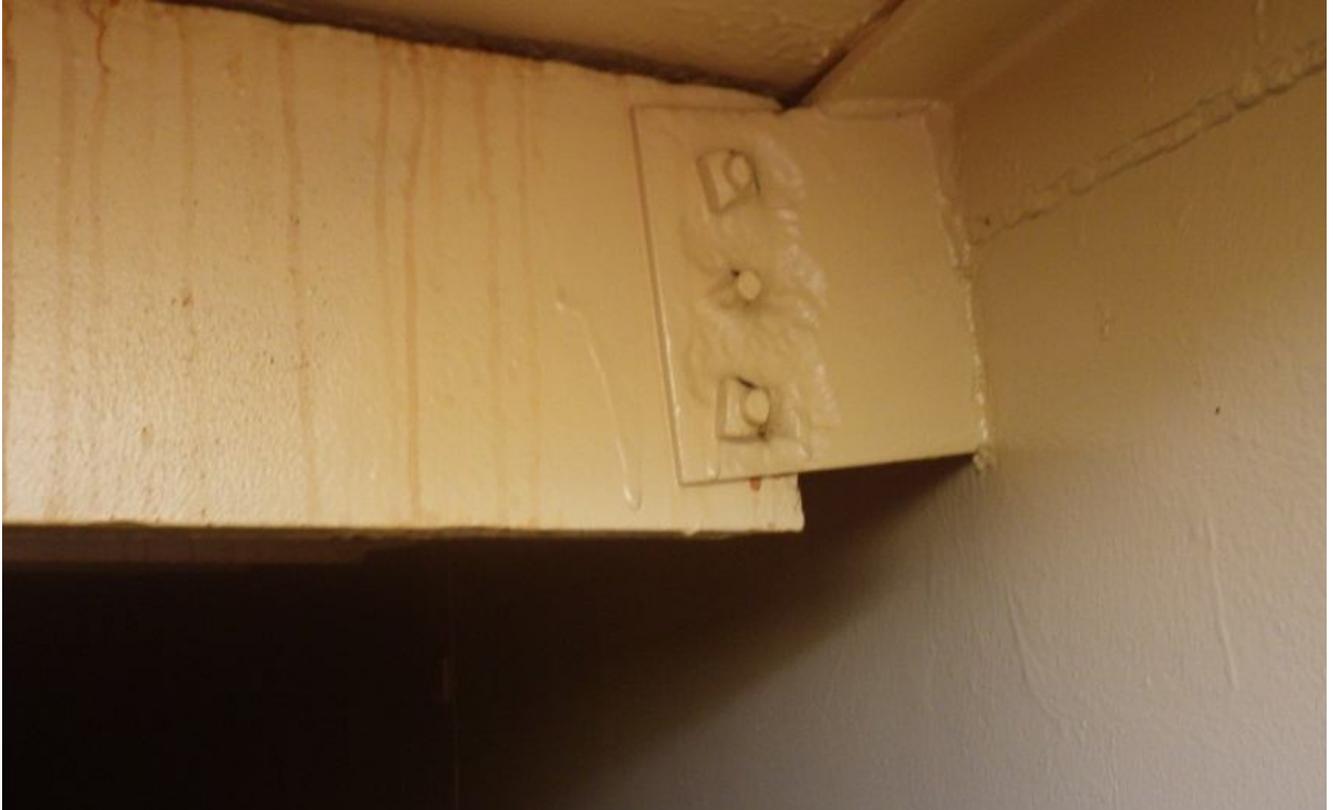
supported the circumferential girders on which the intermediate ends of the roof rafters rested. The outer ends of the rafters were bolted to steel clips which were welded to the shell. Rust staining was located along the top of the roof rafters with minor active corrosion and pack rust along lap seams. It appeared that previous pack rust had been painted over along the roof-to-shell connection, along the rafter flanges, purlins, rafter attachment clips to the shell, and the nuts and bolts in these areas. It appeared some of the nuts and bolts were no longer present. Rafters appeared to be slightly bowed and twisted. Each of the column bases was constructed of four channel members, two triangular plates, two angle clips, and a reinforcing floor plate. Each base was constructed of two parallel channels with two channels welded between them with triangular plates on top reinforcing the connection of the inner channels to the outer channels. The column base channels were intermittently welded to a reinforcing floor plate. One channel of the column was bolted to one of the inner base channels while the other column channel was bolted and welded to two angle clips which were bolted to the second inner base channel. Sensor equipment was located on the roof. (See photos 54-68, 72-77)

64. Rafter and attachment clip to shell. Note significant previous metal loss and missing nut.

8. **Roof Support Structure:** After abrasive blast cleaning, the roof support structure should be carefully evaluated as metal loss repairs may be necessary at areas where the metal loss was not previously visible. Any missing nuts or bolts should be replaced immediately.

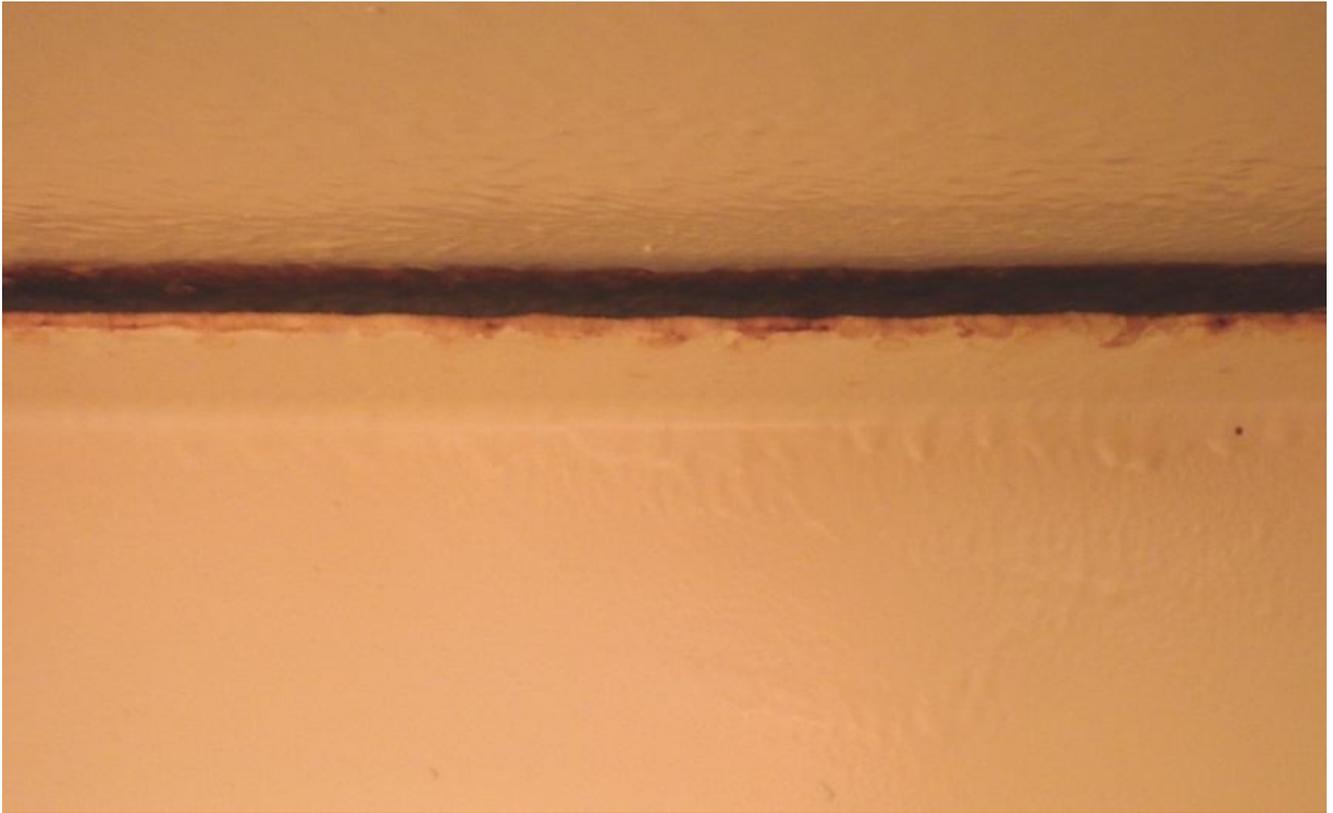
65. Rust between roof and rafter.

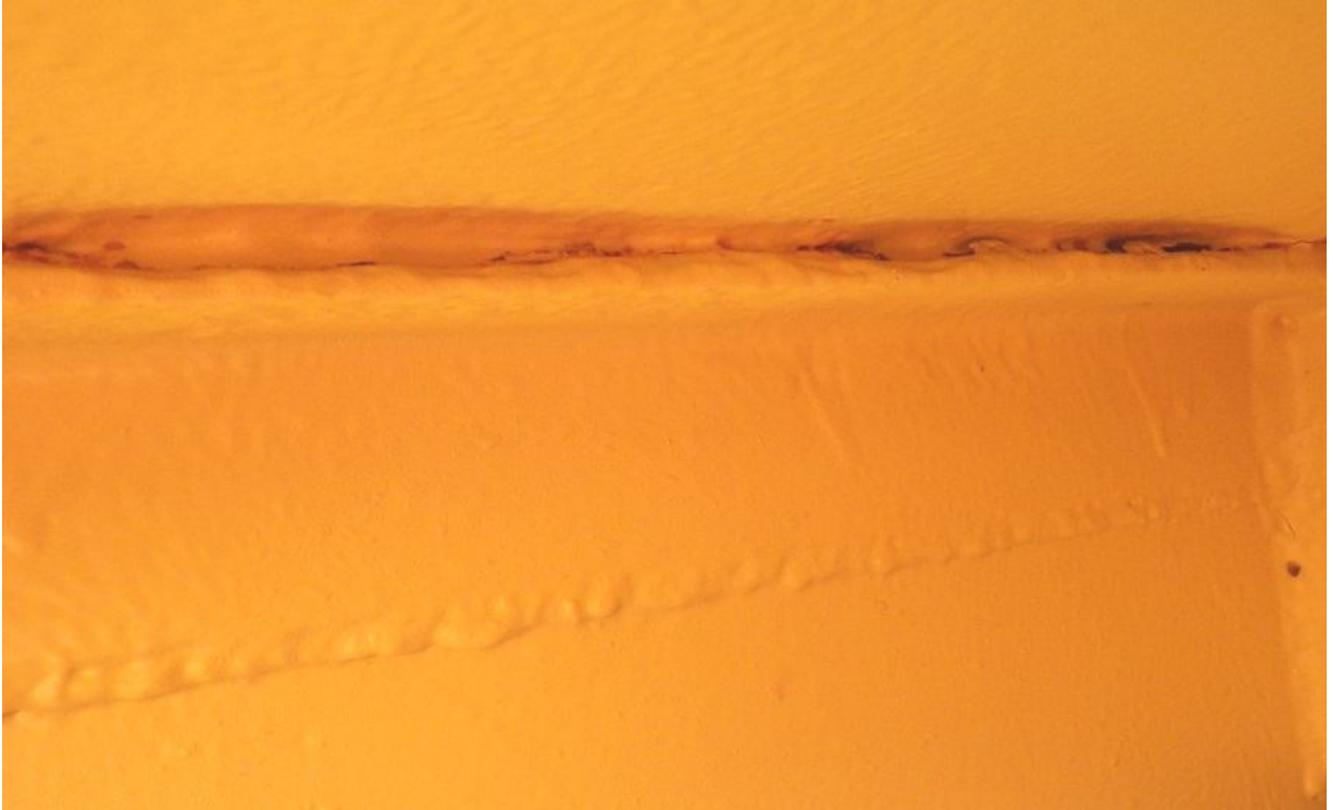
66. Rust between roof and top shell angle.

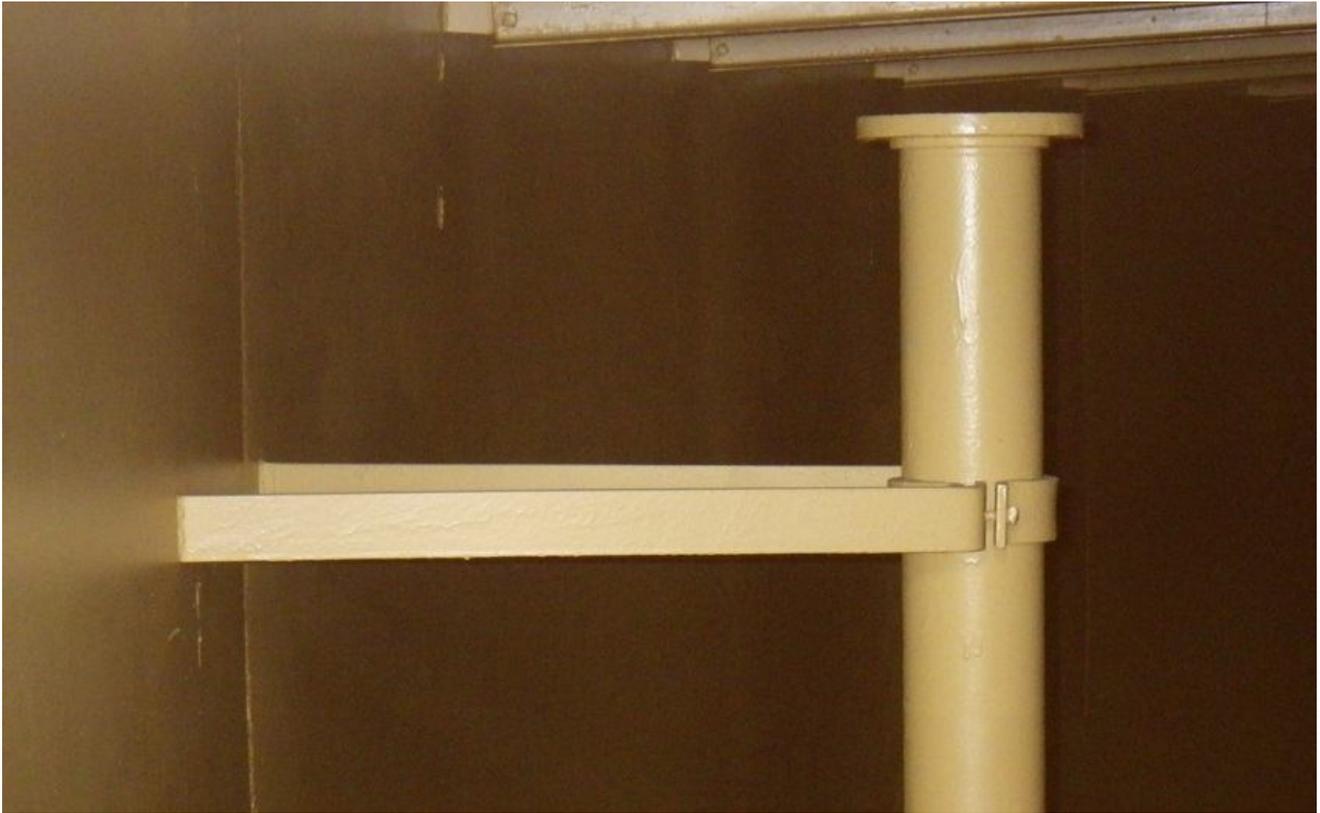
85. Overflow pipe and brackets.

6. **Overflow Pipe: There were sanitary and operational deficiencies observed: (1) interior overflow pipes are susceptible to ice damage and accelerated rates of corrosion, and (2) the pipe did not contain a visible air break above grade.** The overflow was equipped with an open flange type inlet and was located such that the top capacity level was below the shell-to-roof connection and rafter ends. The pipe extended down the shell before exiting the floor. The overflow pipe was flat bar banded to brackets which were welded to the shell. No significant corrosion was observed on the overflow pipe and brackets at the time of the field evaluation. (See photos 71, 80, 82, 85)

9. **Overflow Pipe:** Overflow pipes on the interior of tanks are exposed to the potential of ice damage and accelerated corrosion and metal loss rates. This results in the potential of pipe damage and an unanticipated tank draining. Additionally, overflow pipes without visible air breaks allow for a potential cross-connection. Therefore, Tank Industry Consultants and the AWWA Standard D100 recommend relocating the pipe to the tank exterior. The overflow pipe should exit the top shell ring and extend to approximately 24 in. above grade attached to the shell by welded steel brackets. The overflow pipe discharge should be equipped with a screened, counter-weighted flap gate or elastomeric check valve to prevent the ingress of birds, small animals and insects into the tank. The air break should be adequately sized to allow the proper functioning of the new flap gate. The overflow effluent should be directed away from the foundation using a concrete splash block, or if the Owner wants to continue to use the current underground piping, the vertical portion of the underground piping should be equipped with an air break and a large funnel to direct the overflow effluent into the pipe.
