ITB # 201901 – Strothers Lane Tank

Questions & Answers

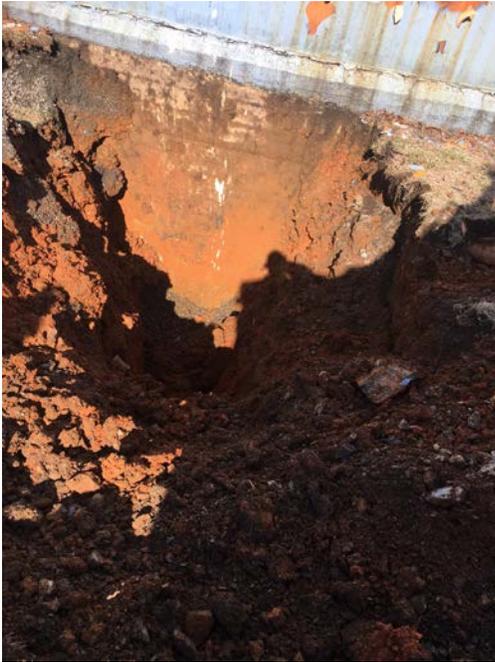
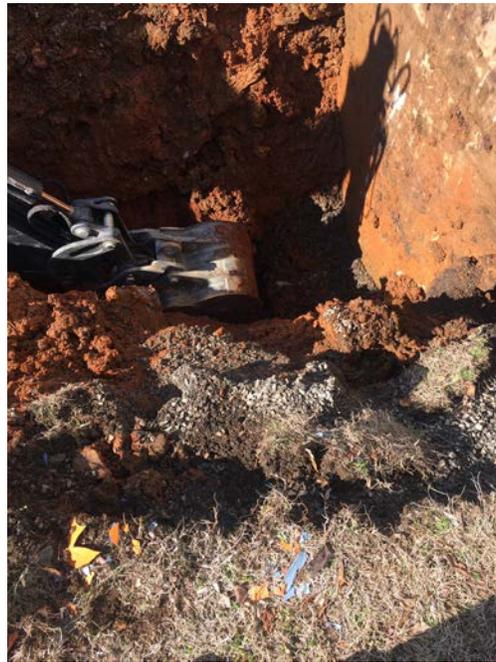
Q45. How deep is the tank?
A45. Test digging shows that there is an approximately 3' wide ring wall that is approximately 9 feet deep. Pictures taken during excavation are provided.

Q44. Is there any information regarding the thickness of the base slab the existing tank is on?
A44. It is not known if there is a base slab below the entire tank. There is a concrete ring wall around the entire circumference, which is approximately 36 inches wide and approximately 9 feet tall.
