**EVALUATION OF THE
3,000,000 GALLON STEEL GROUND STORAGE TANK**

**“STROTHERS LANE TANK”
WINCHESTER, VIRGINIA**

**HAZEN & SAWYER, P.C.
NEWPORT NEWS, VIRGINIA**

August 15, 2017

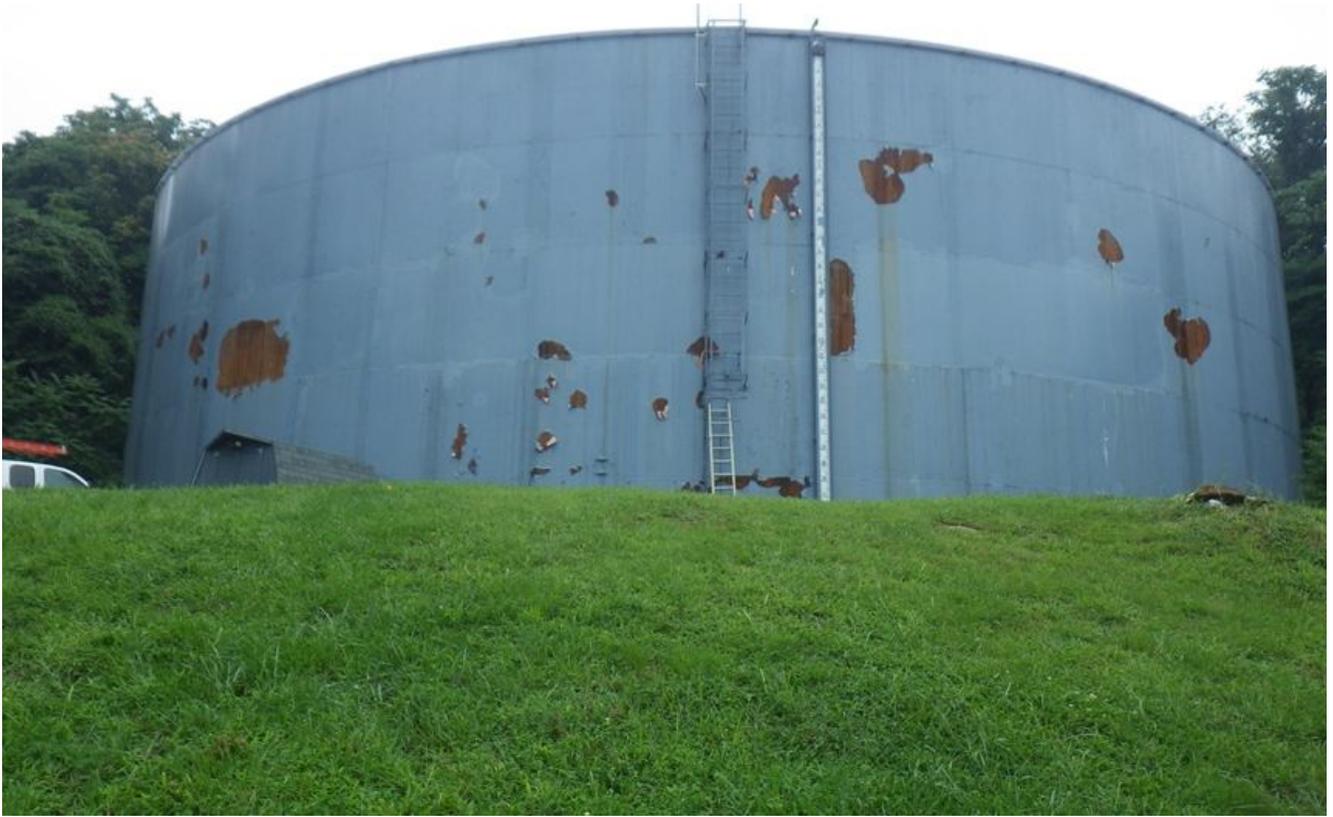
2. **Site Conditions:** The tank site was covered with grass and was graded to provide adequate drainage away from the foundation. The tank site was not fenced. What appeared to be blast media was found on the ground surrounding the tank. Tree limbs were growing in close proximity to the tank. A hydrant was located on the south part of the site. Failed coating chips were located on the ground around the tank. (See photos 1, 11)

1. Tank overview.

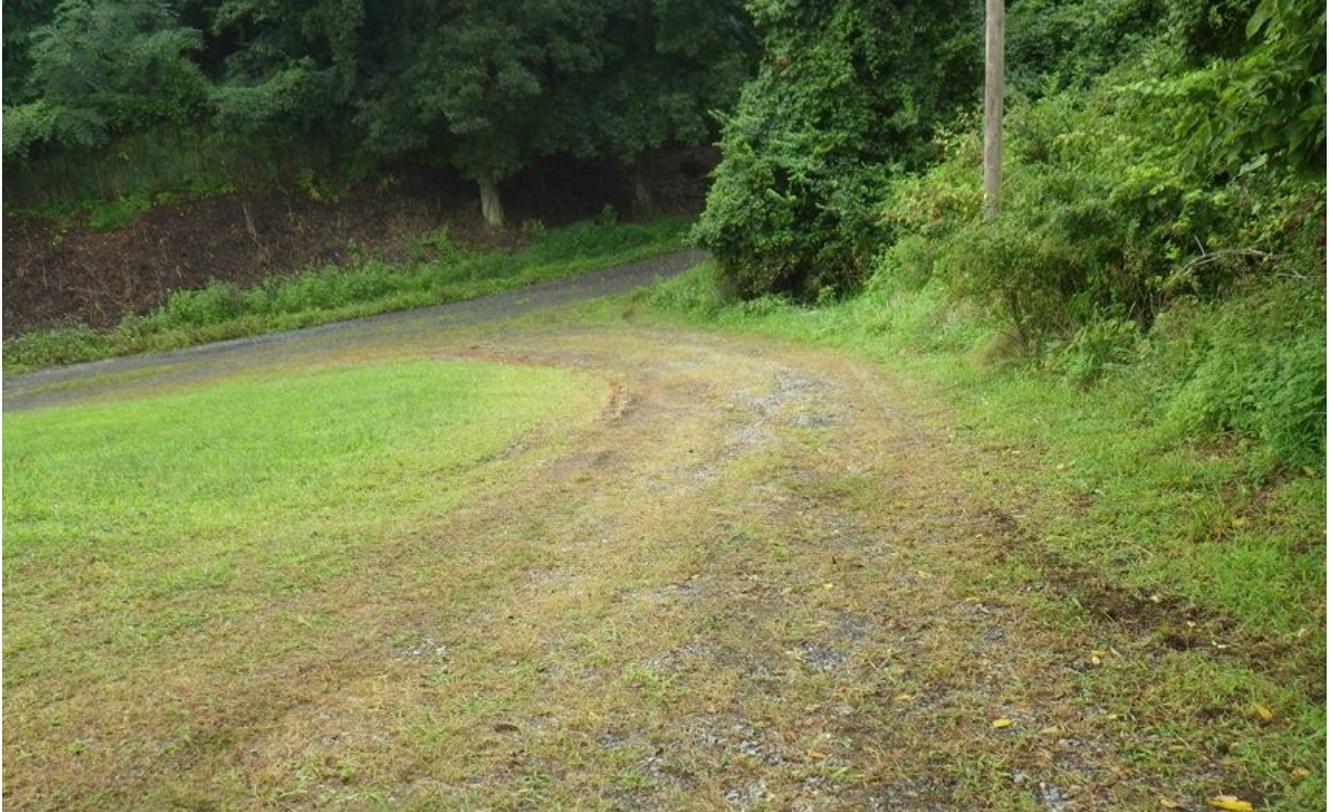
2. Site access.

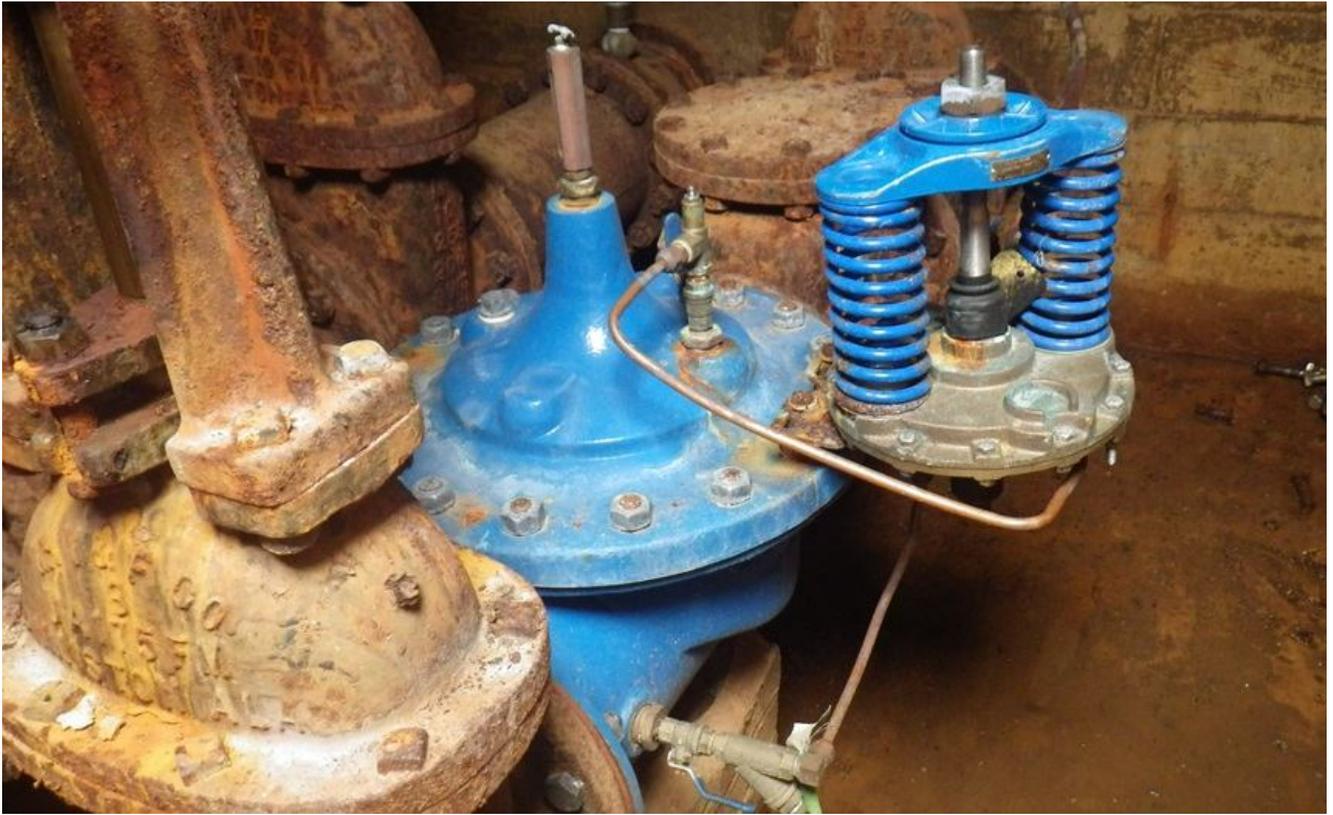
5. **Valve Vault: There were safety and OSHA deficiencies noted: (1) the 8-1/2 in. access rung width did not meet the required 16 in. minimum, (2) the 14-3/4 in. to 15-1/4 in. spacing between access rungs did not comply with the requirement for rungs to be spaced at consistent intervals no more than 14 in. apart, and (3) the 24-1/2 in. head clearance did not meet the minimum required 30 in.** There was a valve vault attached to the south side of the foundation. Access into the valve vault was locked prior to or after this field evaluation. The piping in the valve vault was generally rust covered, with layering corrosion and metal loss on piping nuts and bolts. A drain was located in the vault floor. (See photos 5-10)

7. Valve vault piping.

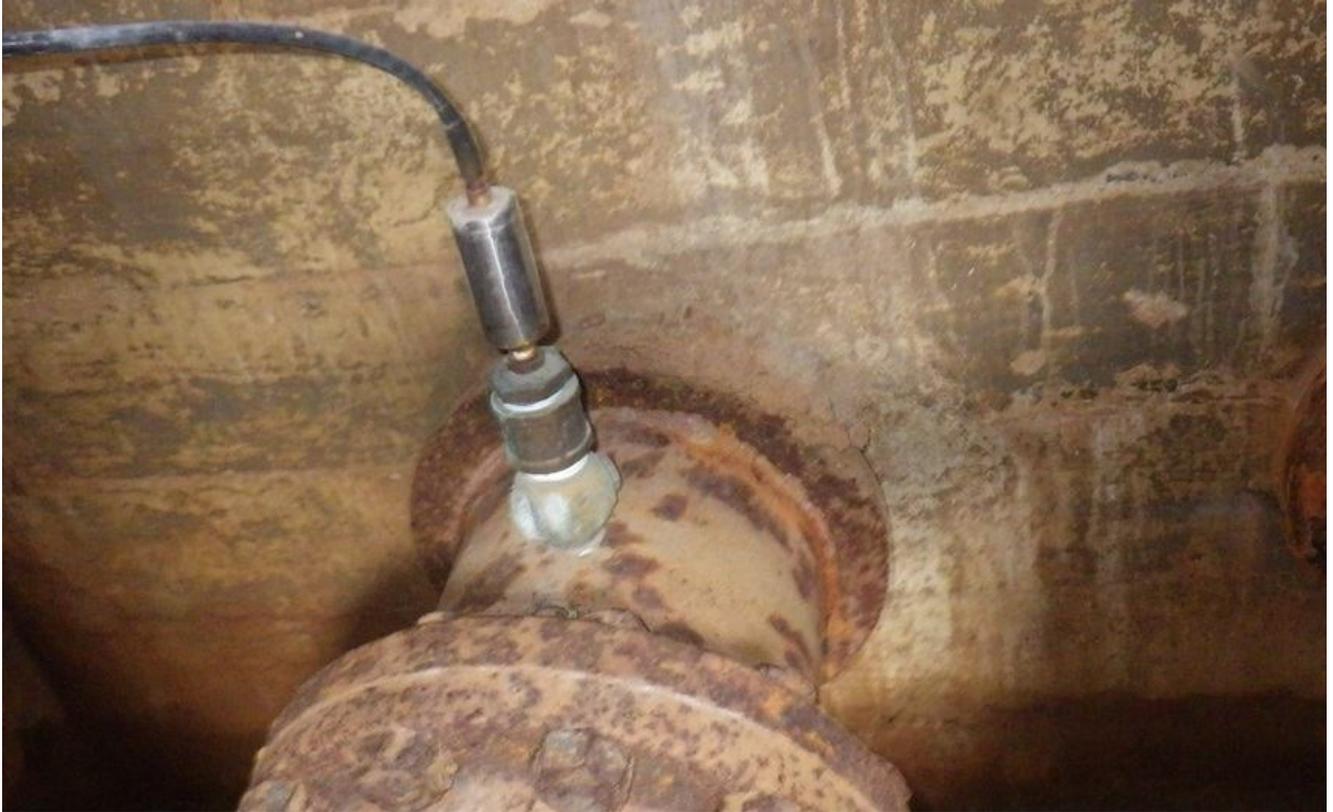
8. Valve vault piping.

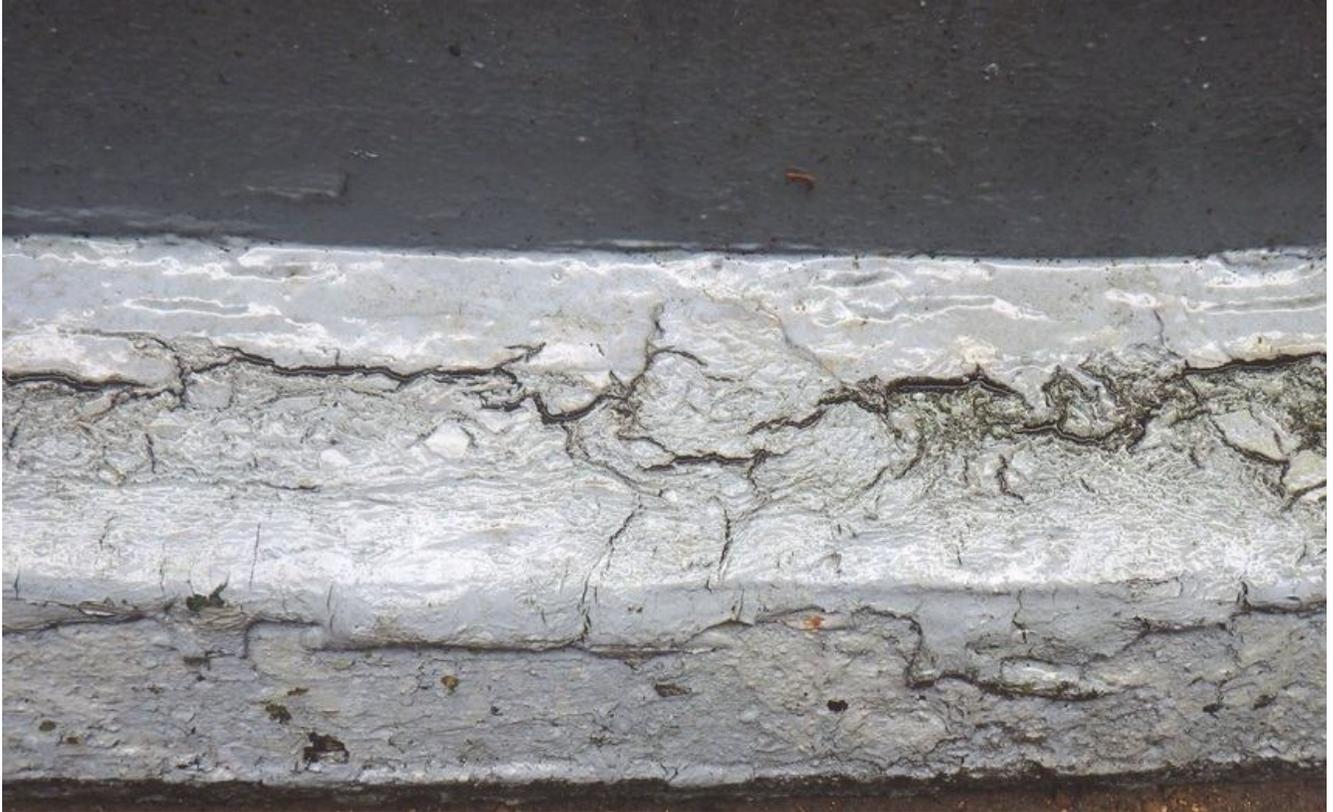
3. **Foundation:** The tank foundation appeared to be a concrete ringwall. Much of the foundation was covered with sealant limiting the surfaces which could be viewed. Cracking, spalling, erosion, and small surficial holes were observed in the concrete foundation at the time of this field evaluation. The foundation sounded hollow when struck. The foundation exhibited the AWWA recommended 6 in. to 12 in. projection above grade, and exceeded it in other areas. Coating was visible on the exposed concrete surfaces at the time of this field evaluation. (See photos 12-14, 16)

16. Foundation.

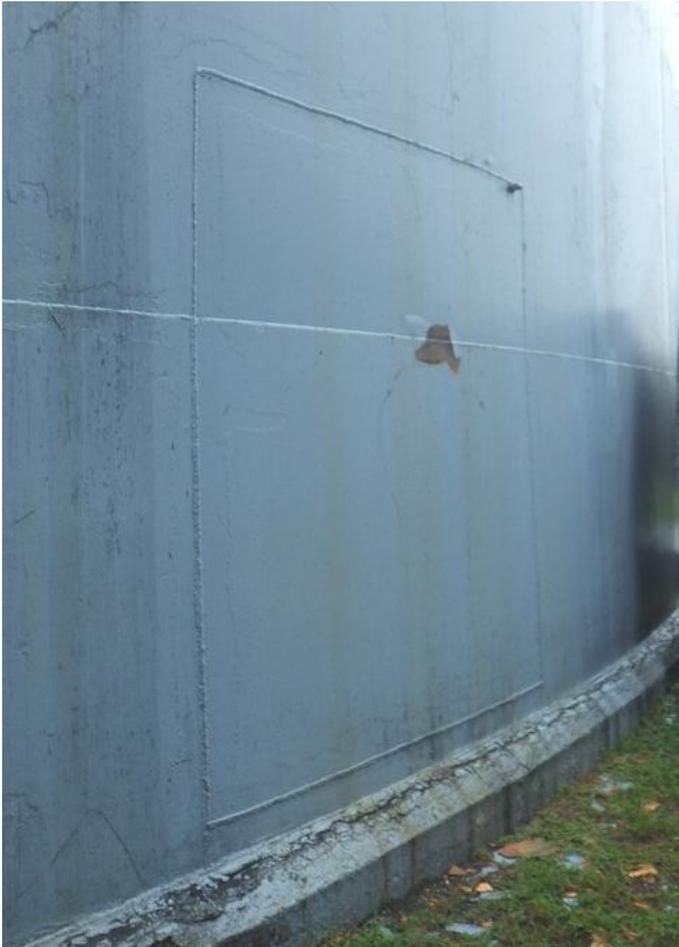
- ◆ a welded steel door sheet in the shell did not contain rounded corners.

18. Exterior shell. Note door sheet.

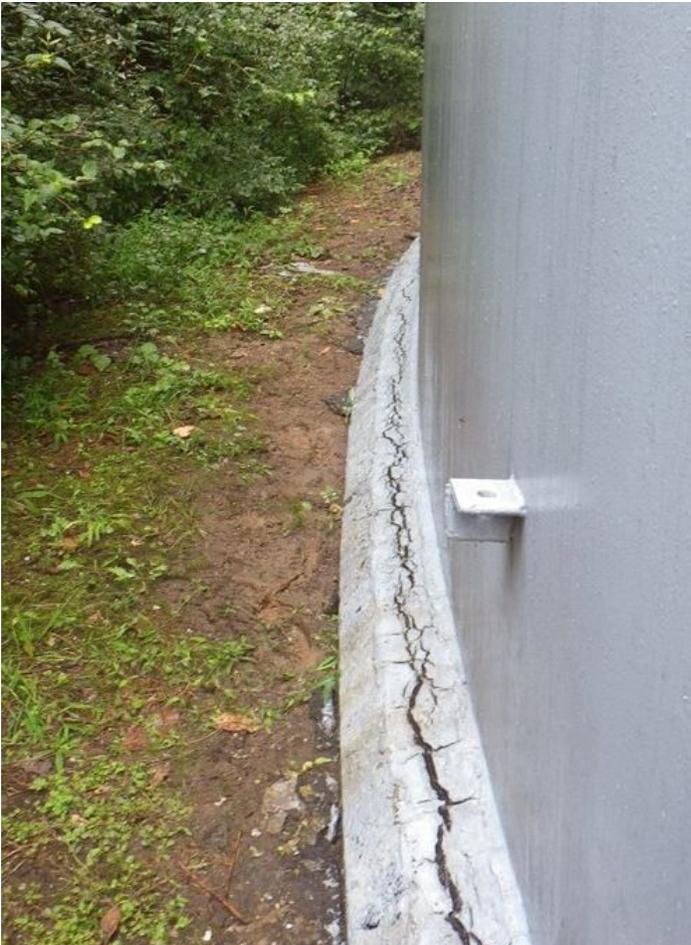
20. Exterior shell. Note unused bracket.

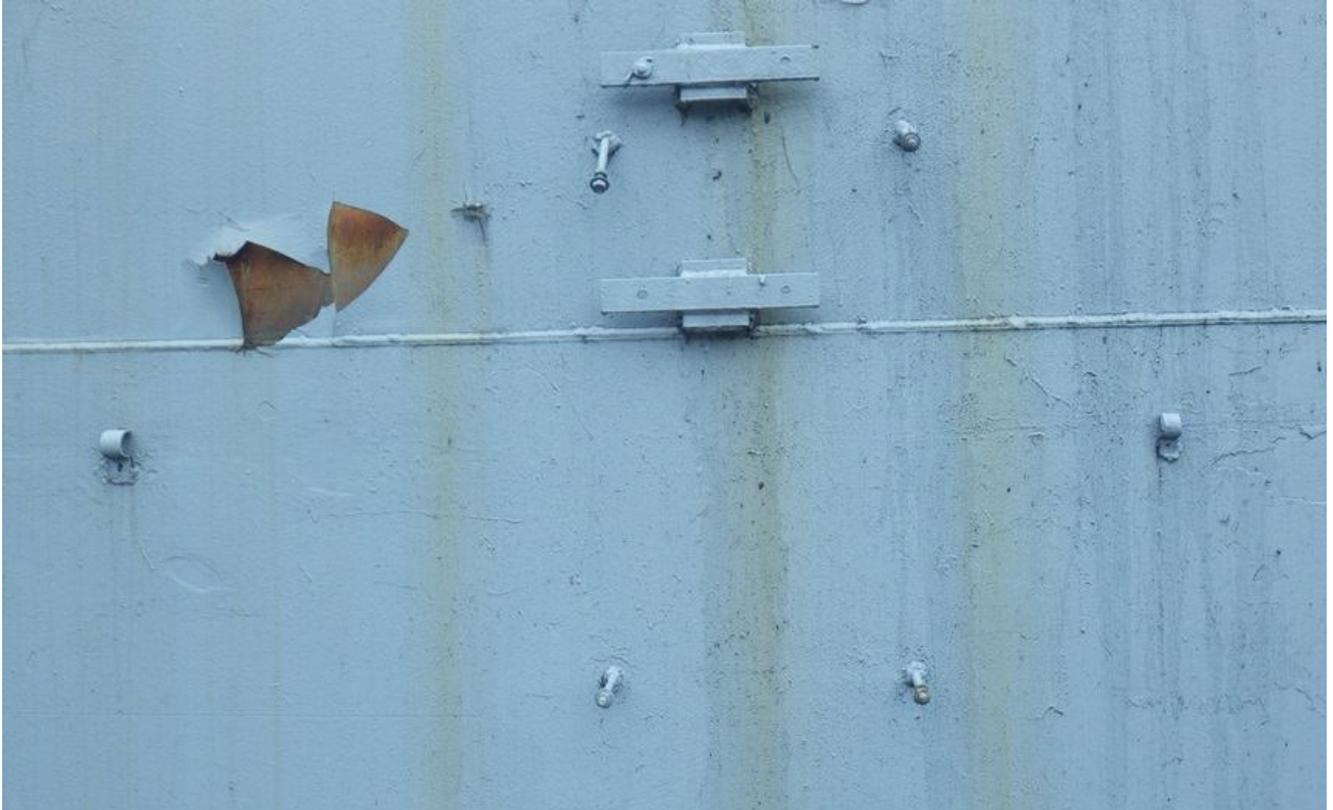
22. Unused brackets on exterior shell.

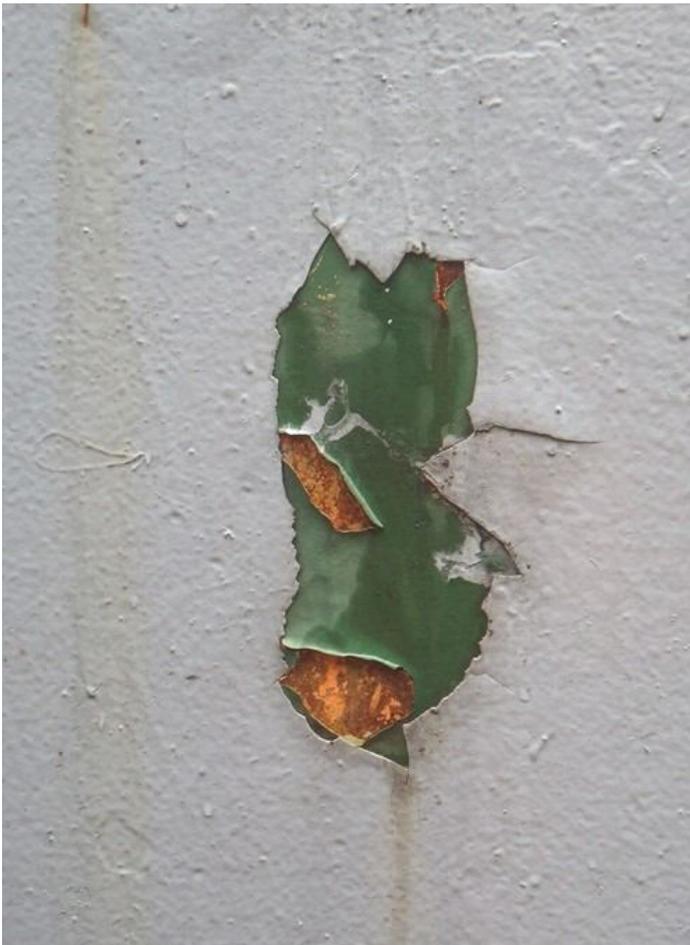
24. Peeled coating on shell.

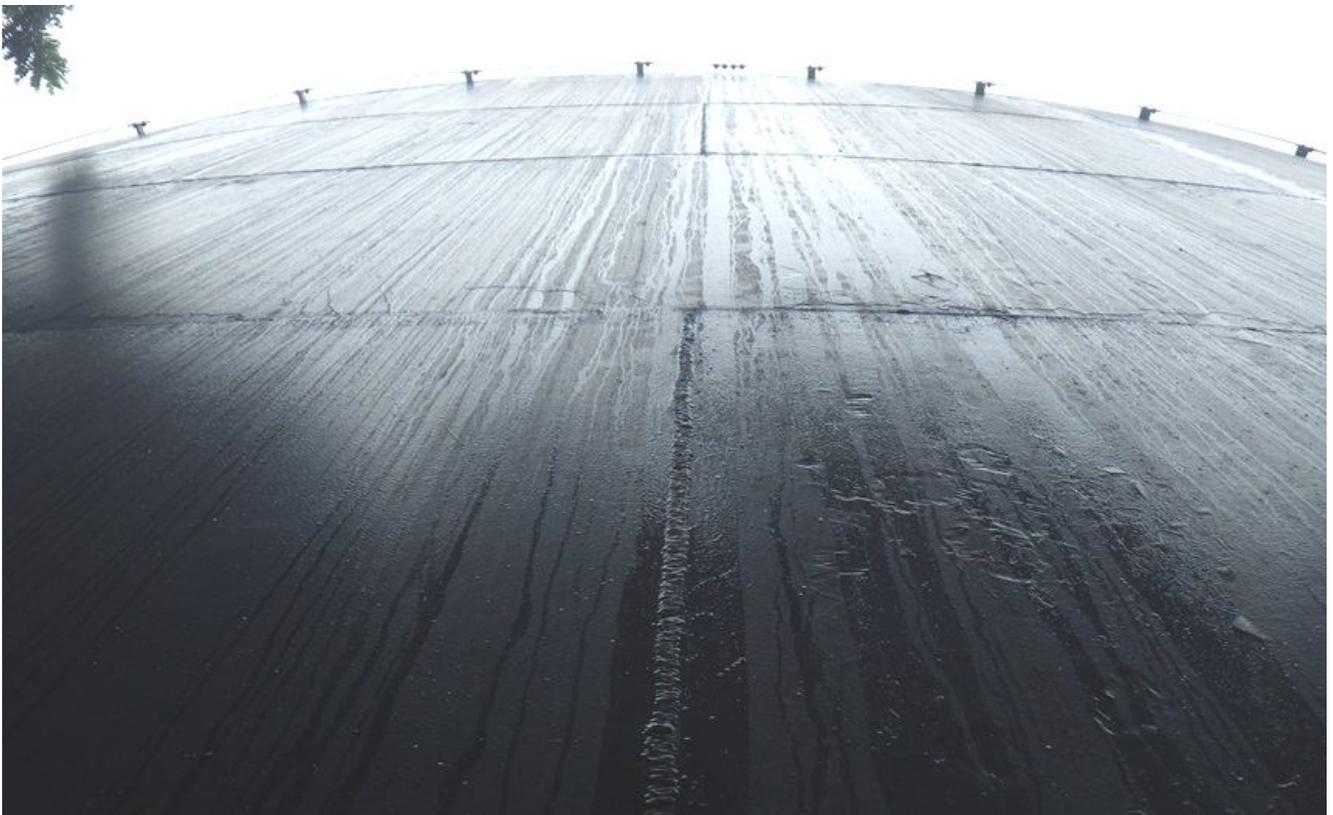
26. Exterior shell. Note proximity of tree branches.

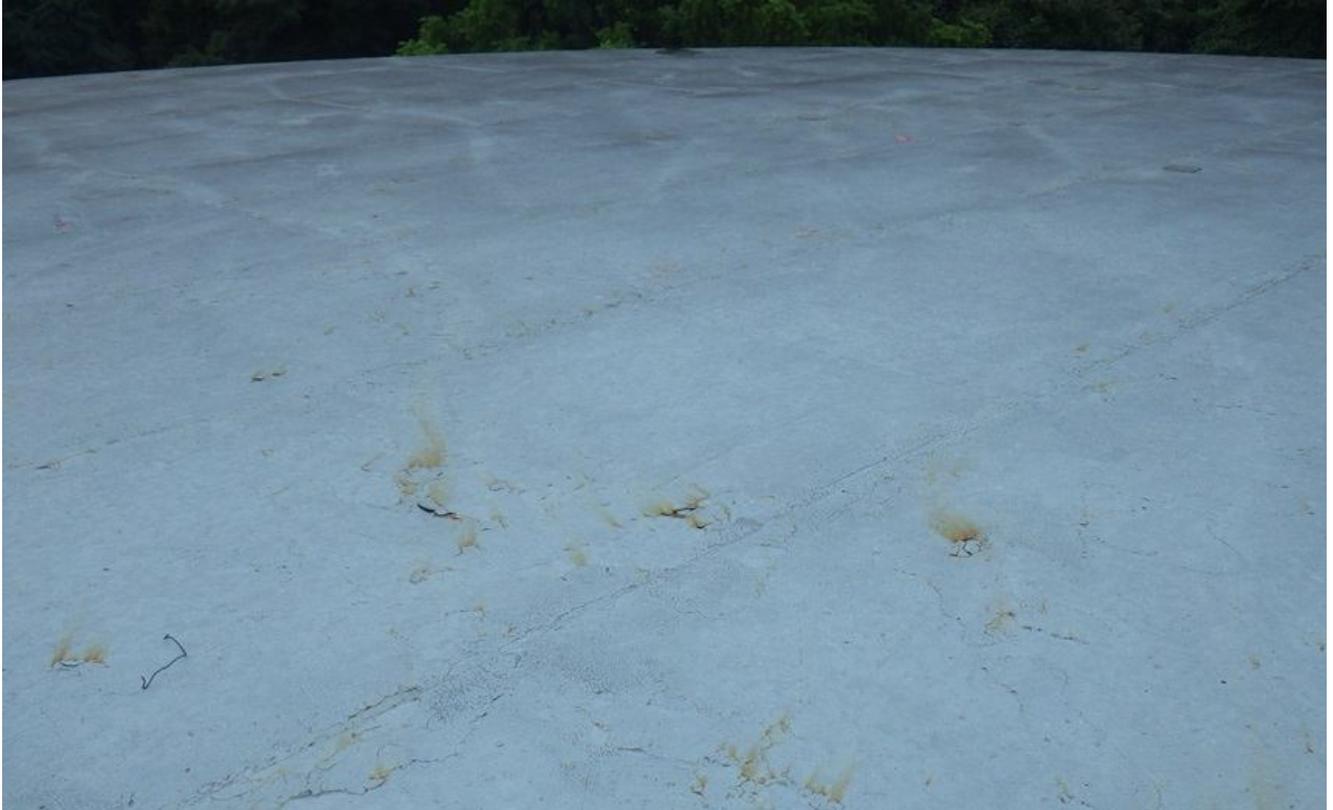
42. Exterior roof.

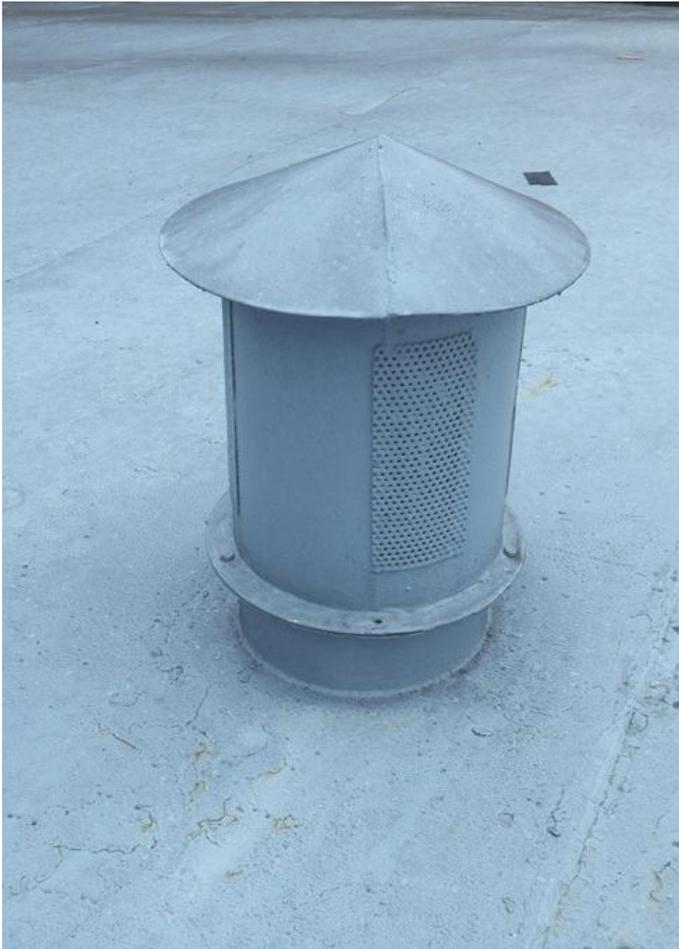
45. Roof vent.

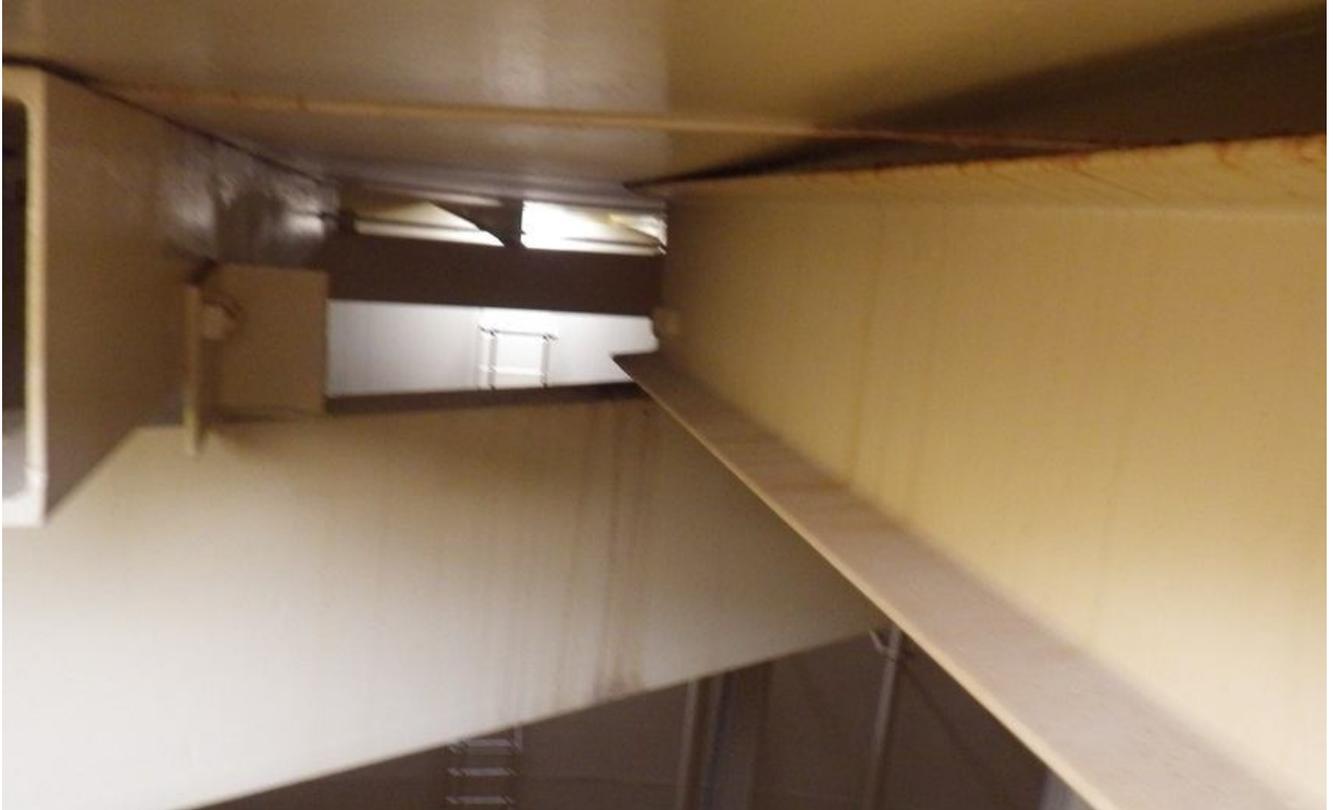
56. Roof support structure.

The coating on the exterior was in very poor condition with widespread areas of peeled coating and corrosion noted. The exterior should be repainted within the next 2 to 3 years. The interior coating was in good overall condition. Any nuts or bolts missing from the roof support structure should be replaced immediately.

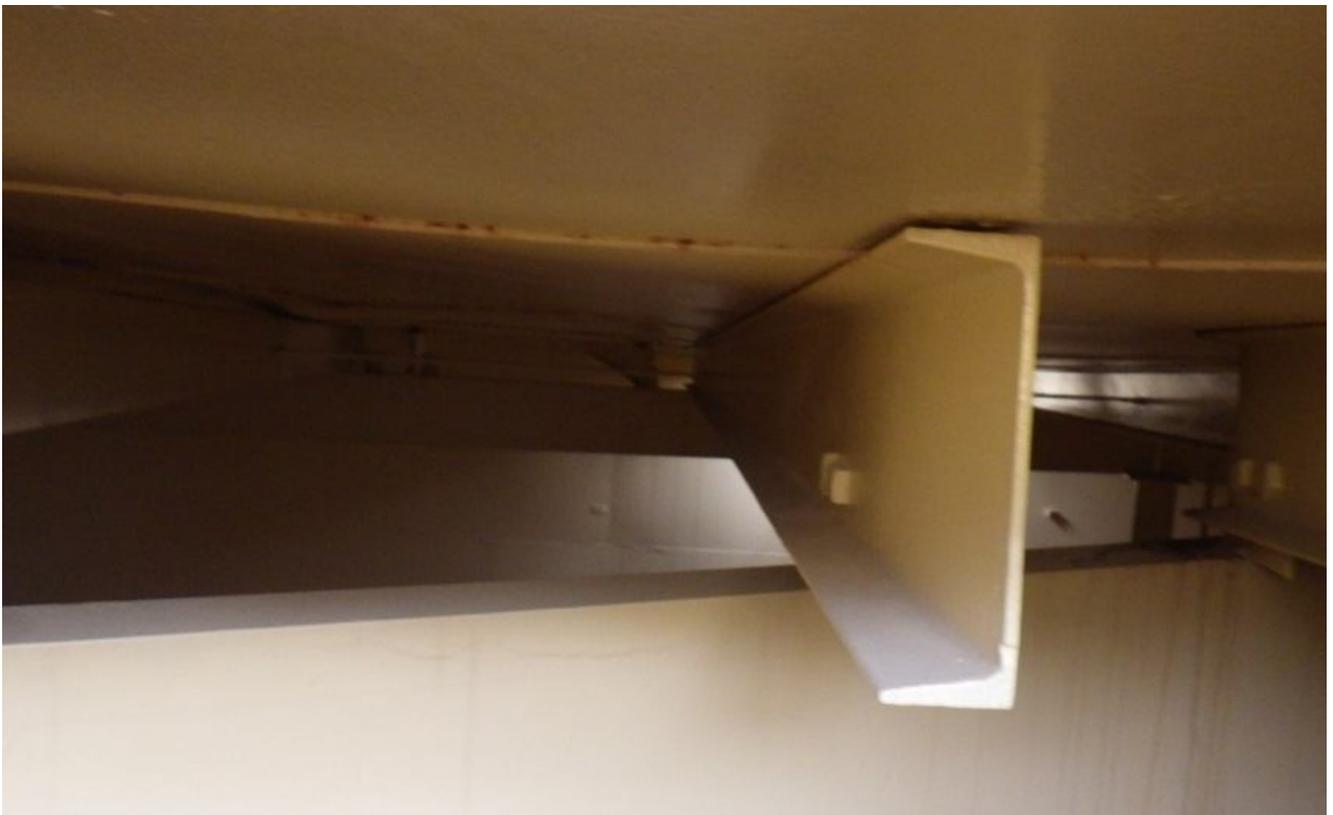
58. Rafter end.

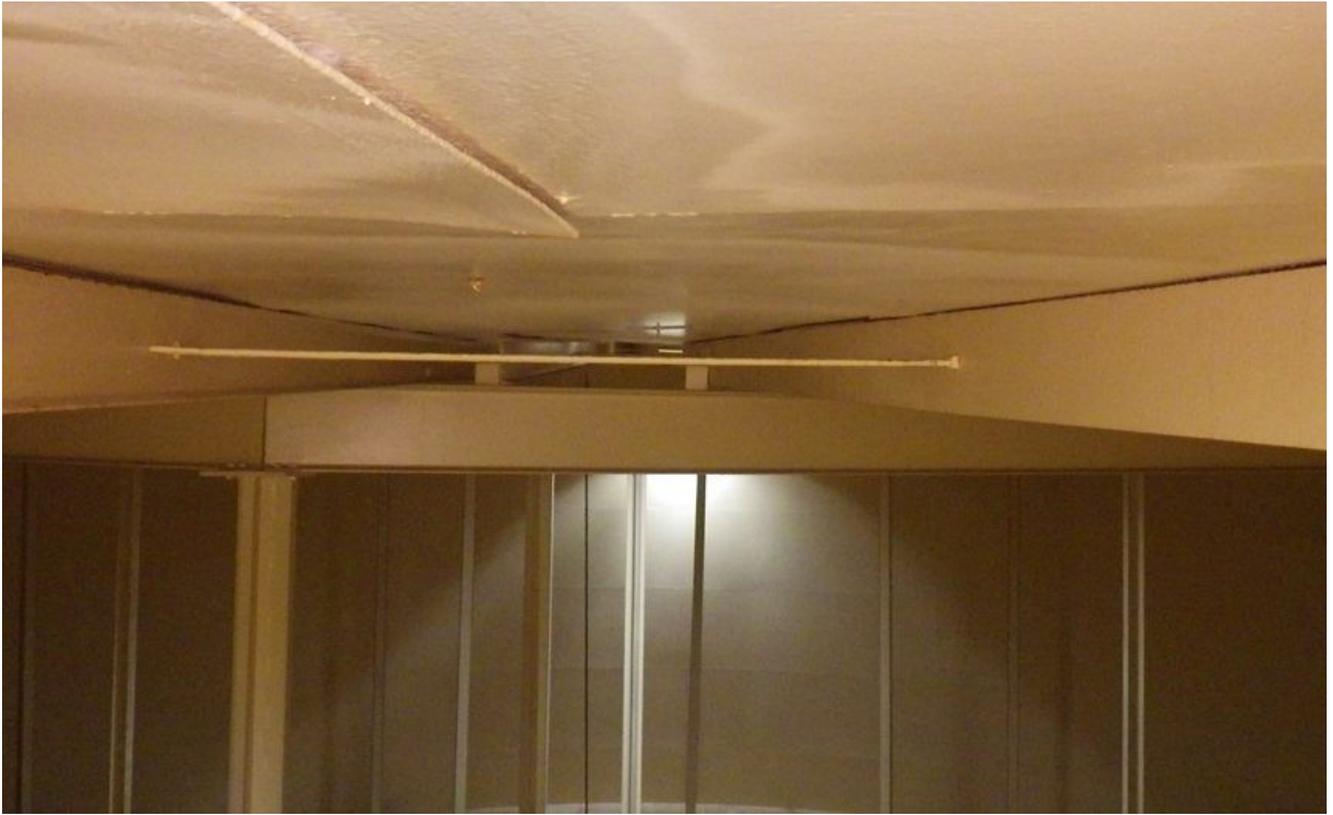
59. Interior roof.

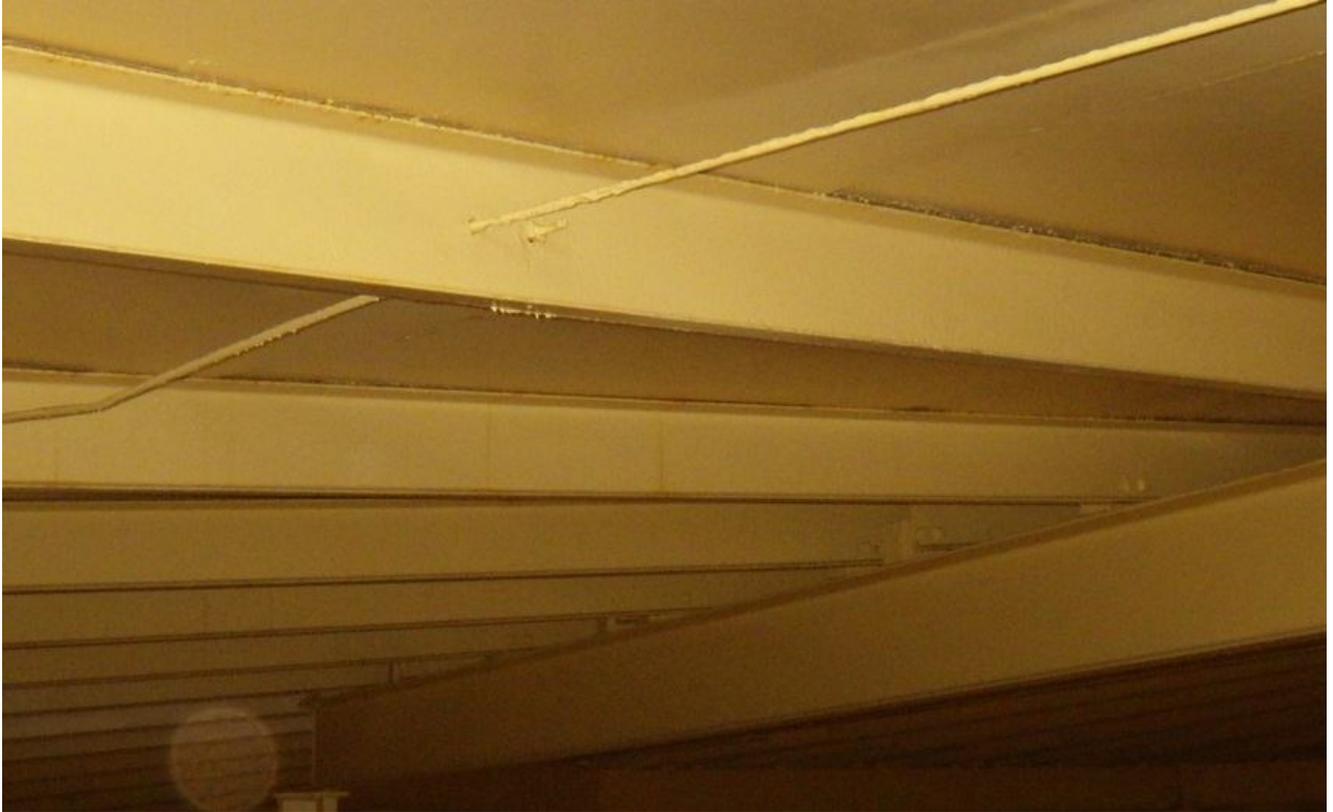
60. Roof rafters and purlins.

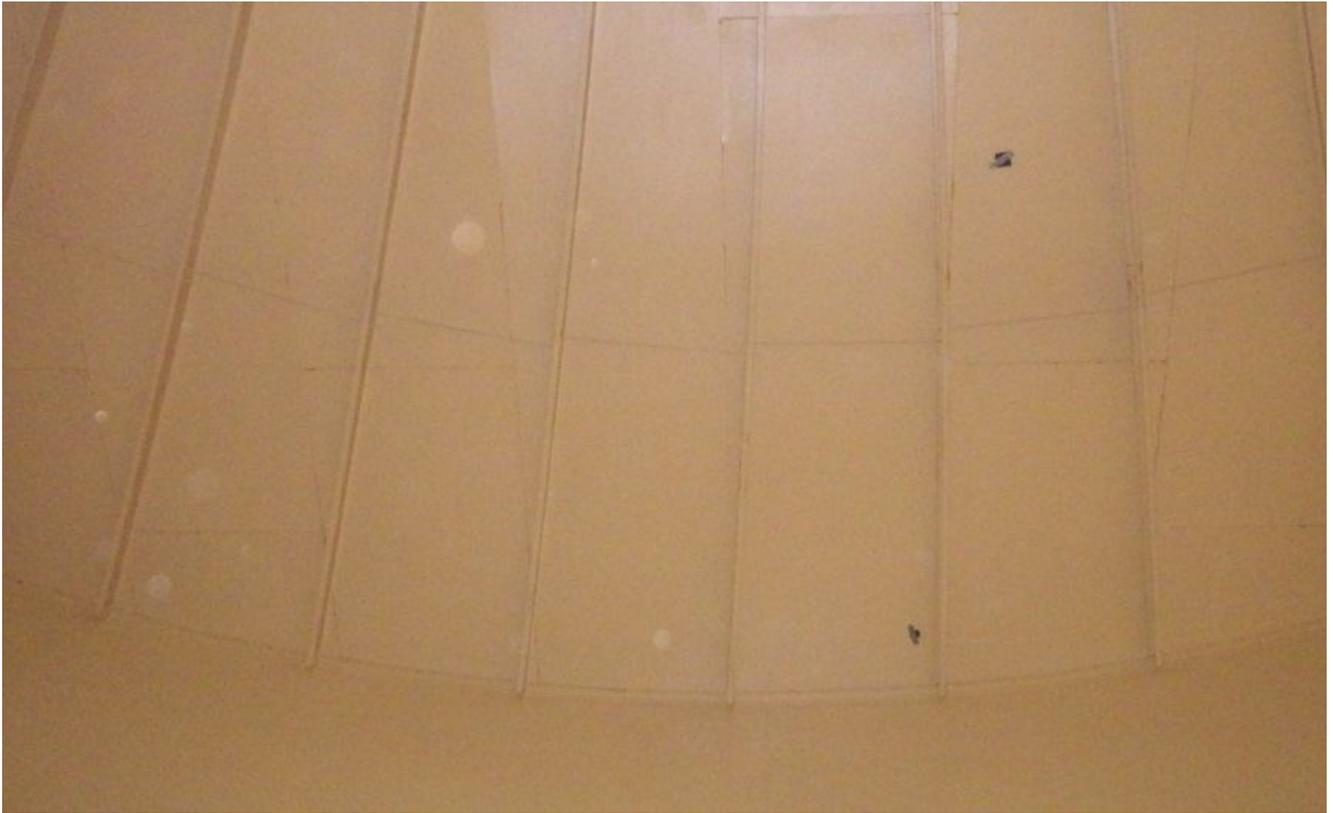
61. Interior roof.

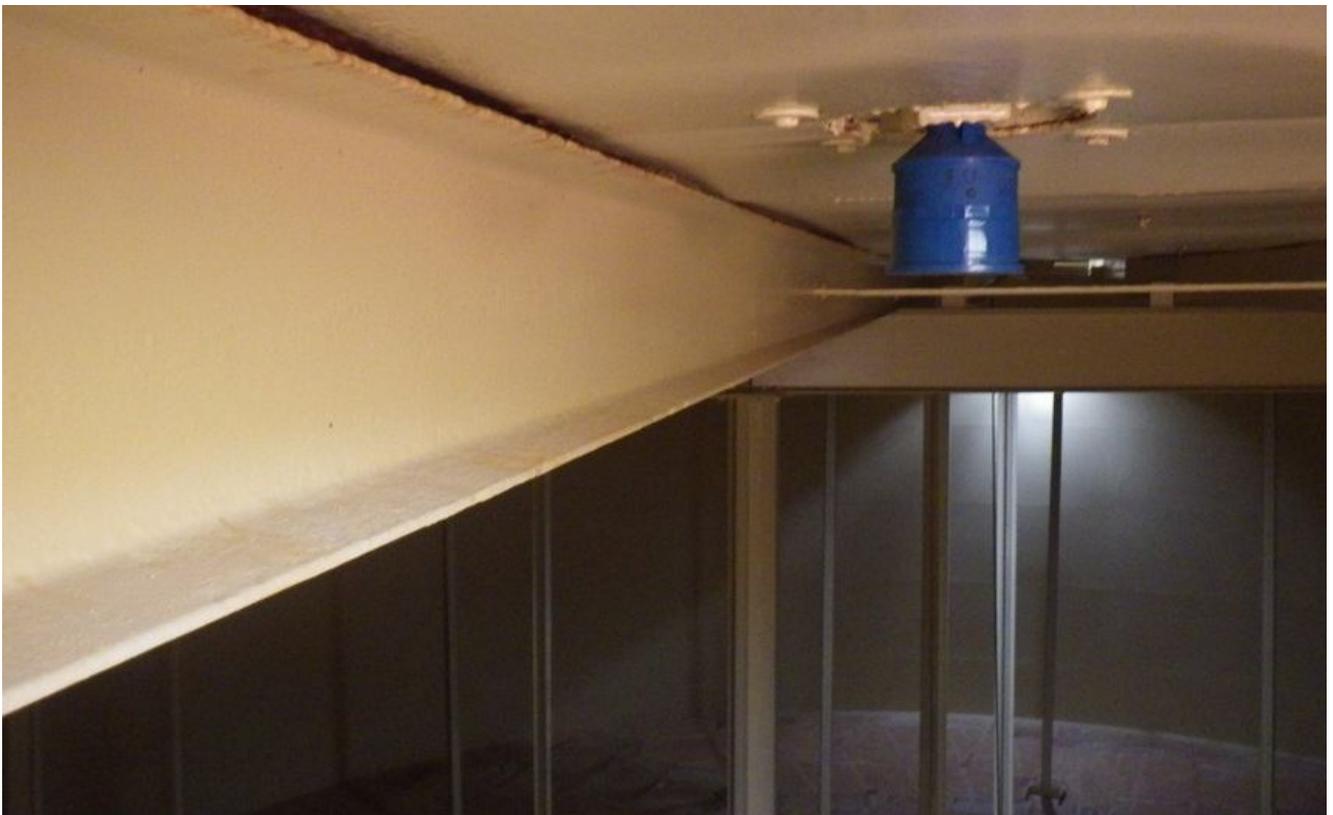
62. Sensor penetrating roof.

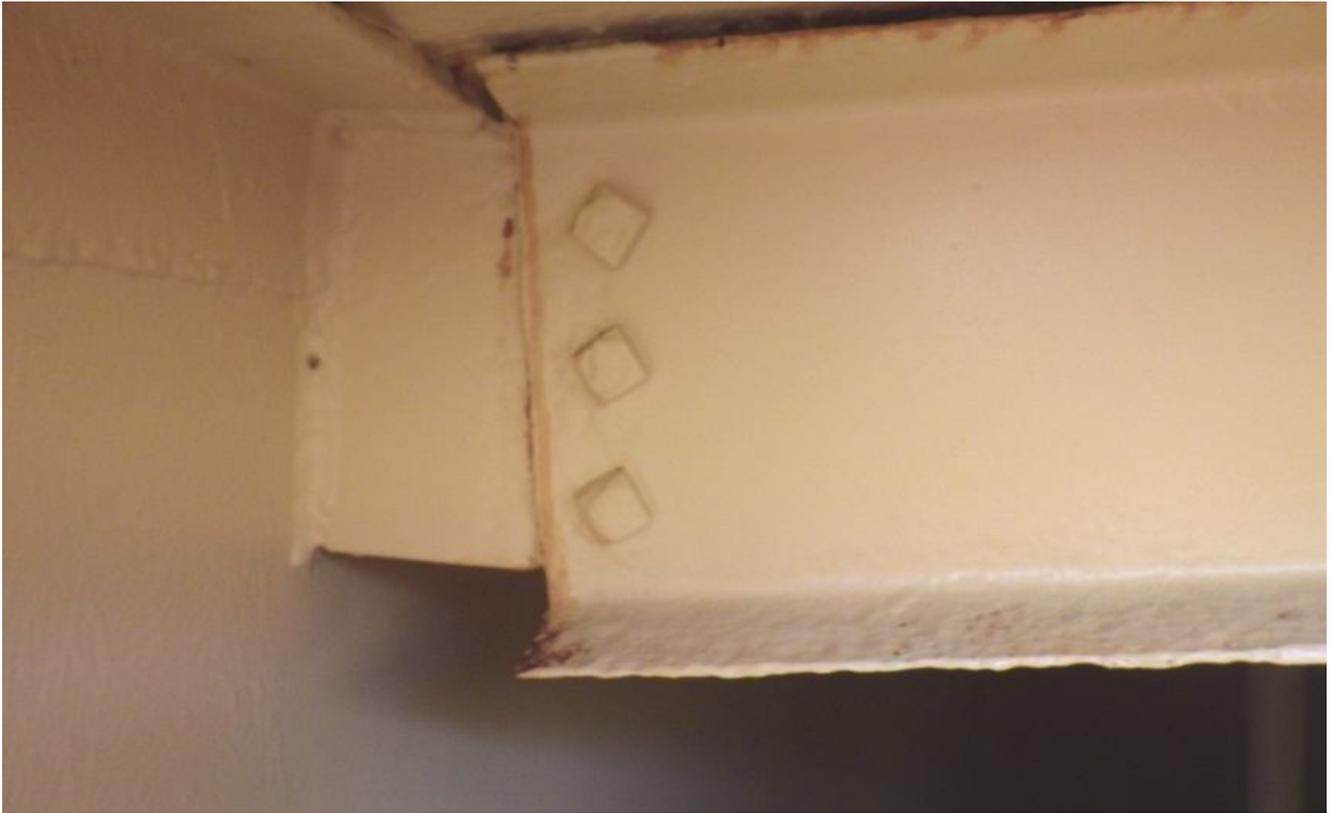
63. Rafter and attachment clip to shell.

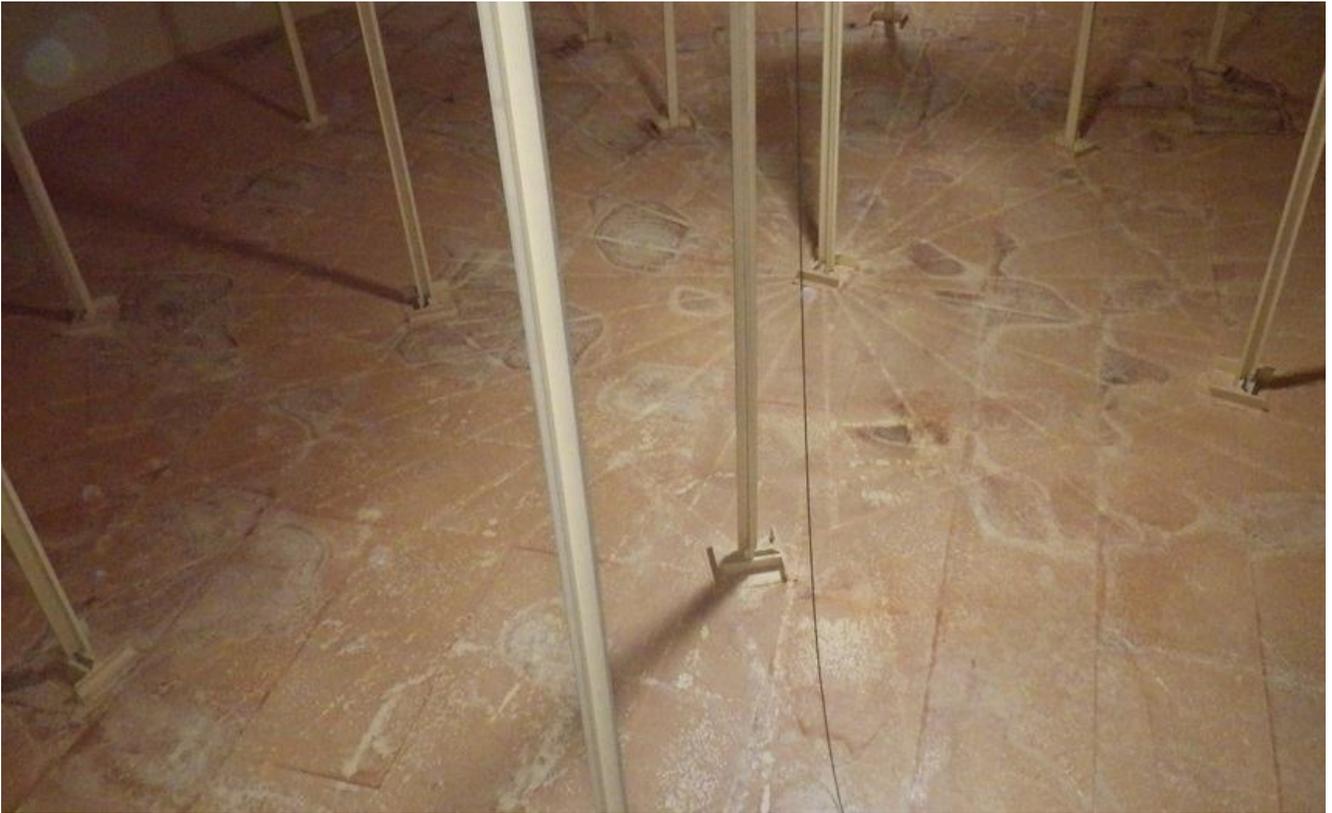
67. Interior floor and columns.

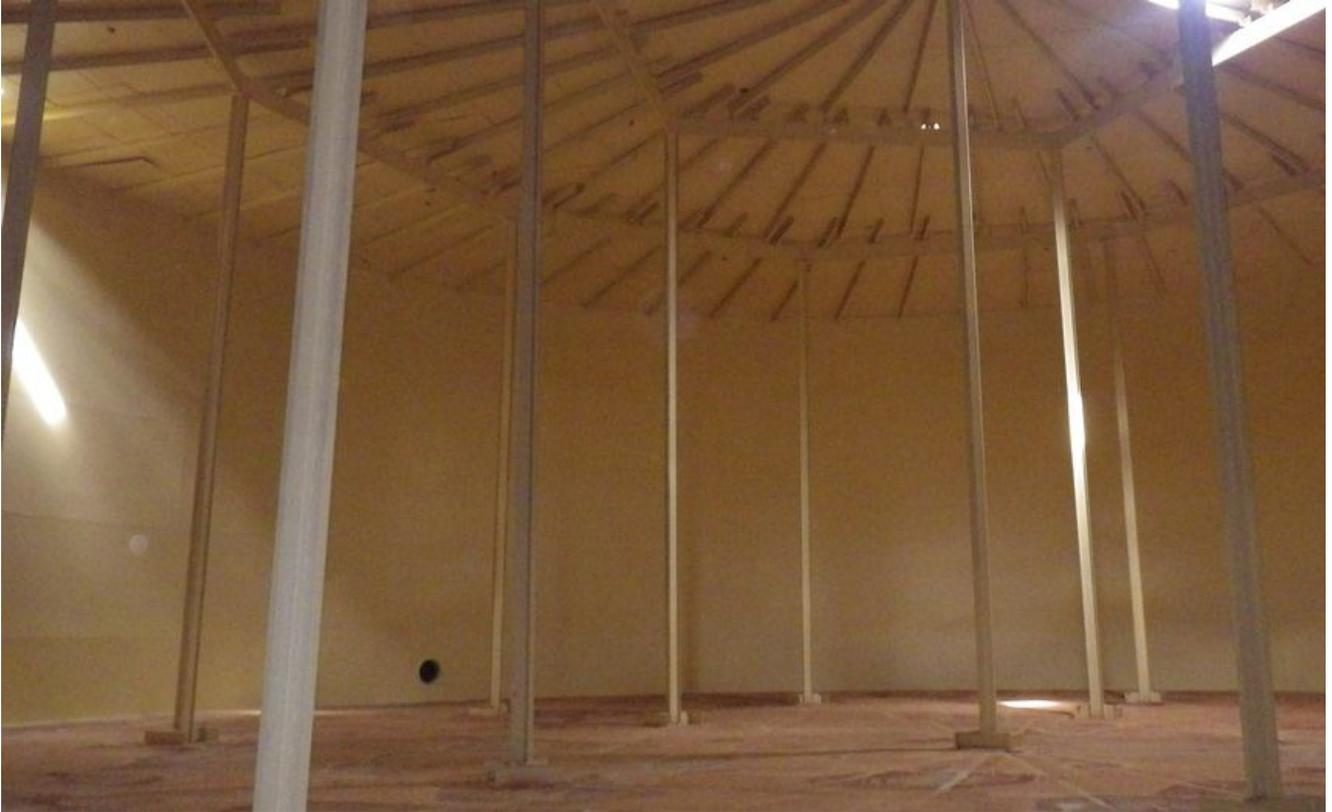
68. Interior container overview.

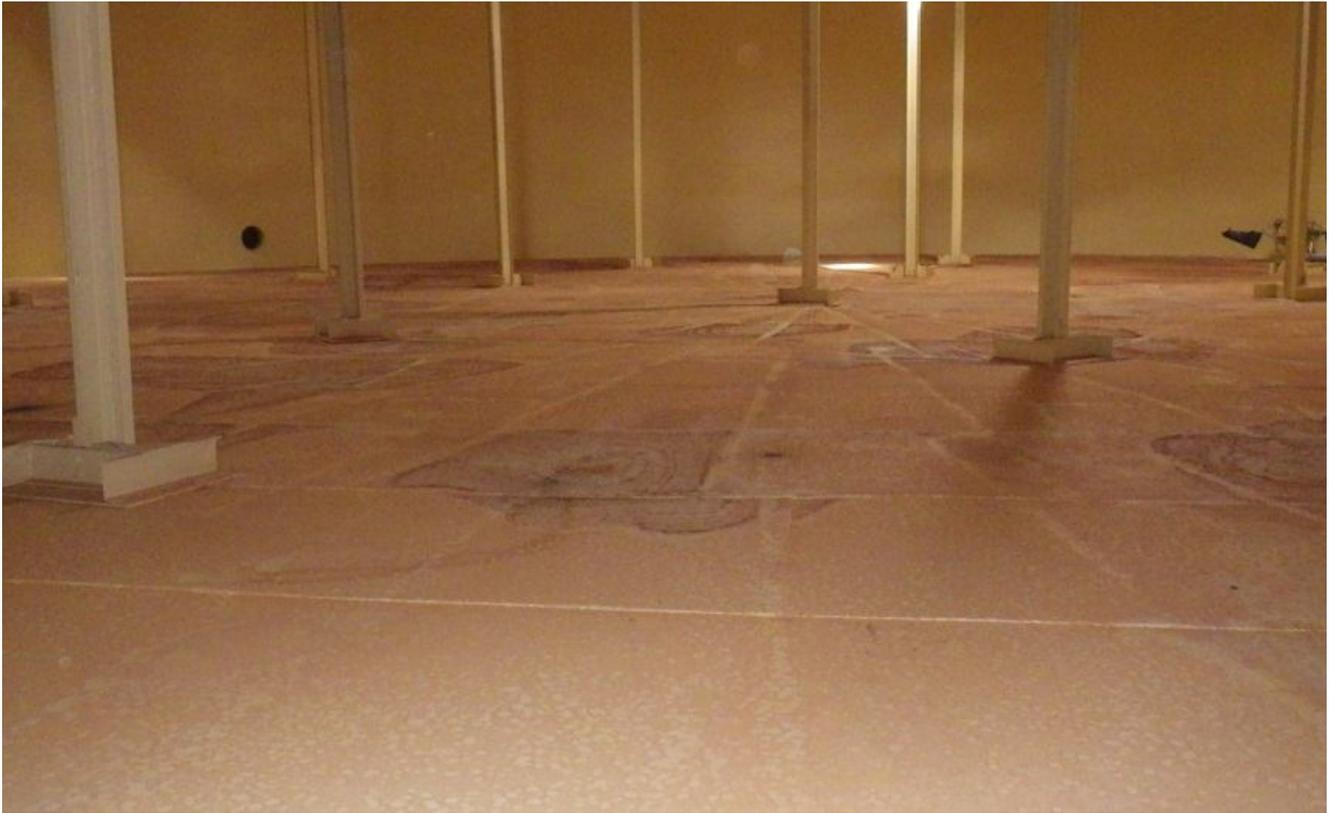
69. Interior container.
