**EVALUATION OF THE
3,000,000 GALLON STEEL GROUND STORAGE TANK**

**“STROTHERS LANE TANK”
WINCHESTER, VIRGINIA**

**HAZEN & SAWYER, P.C.
NEWPORT NEWS, VIRGINIA**

August 15, 2017

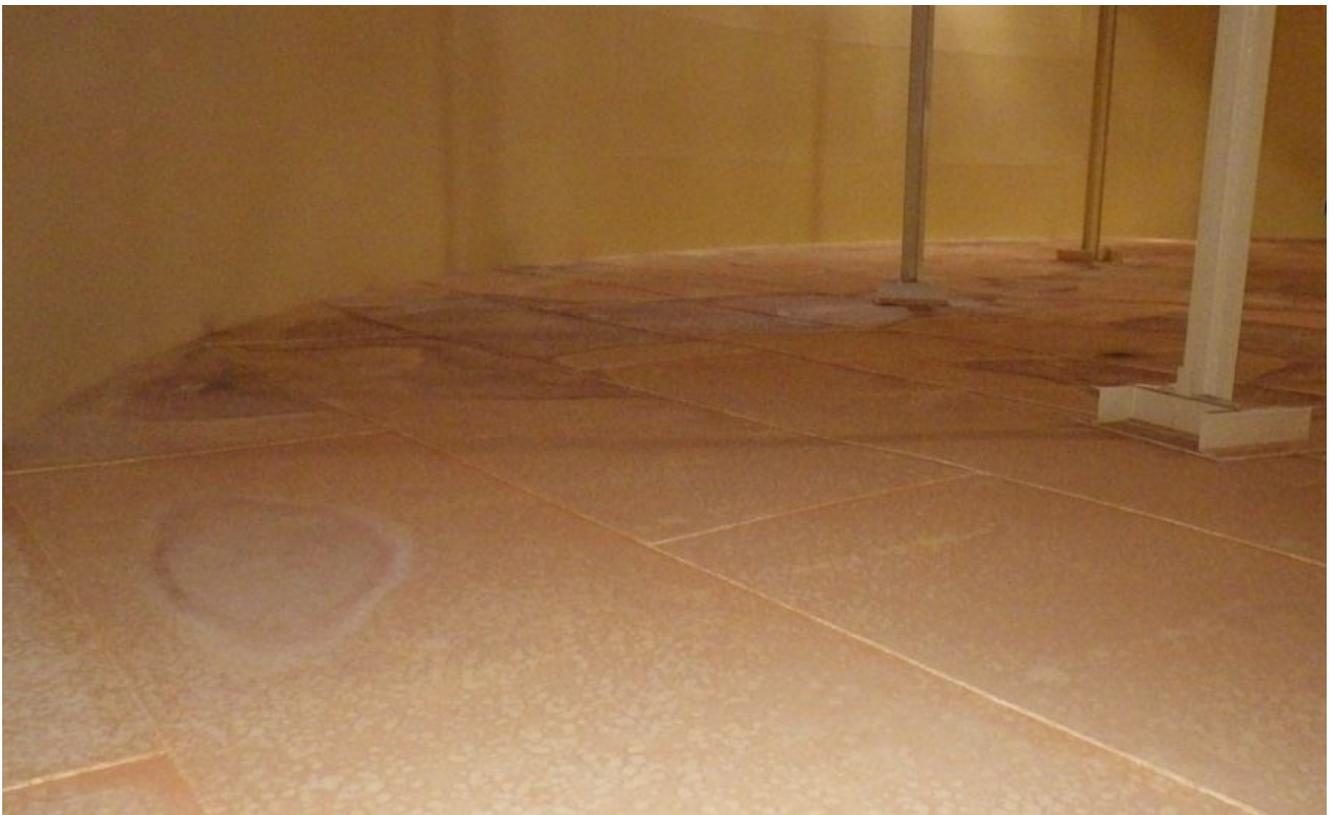
70. Interior container.

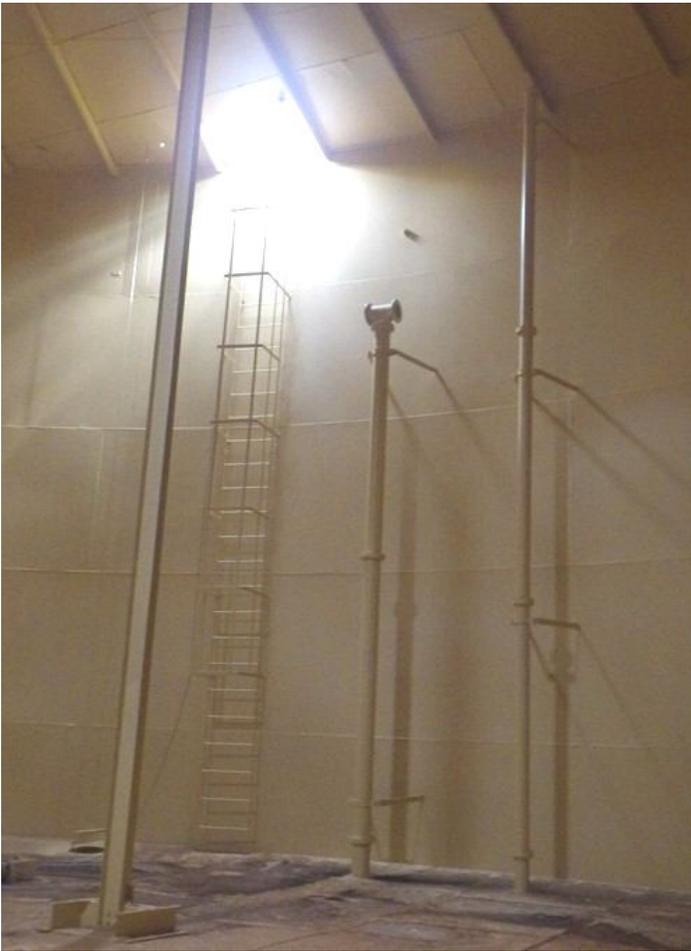
71. Interior ladder, safety cage, inlet pipe and overflow pipe.

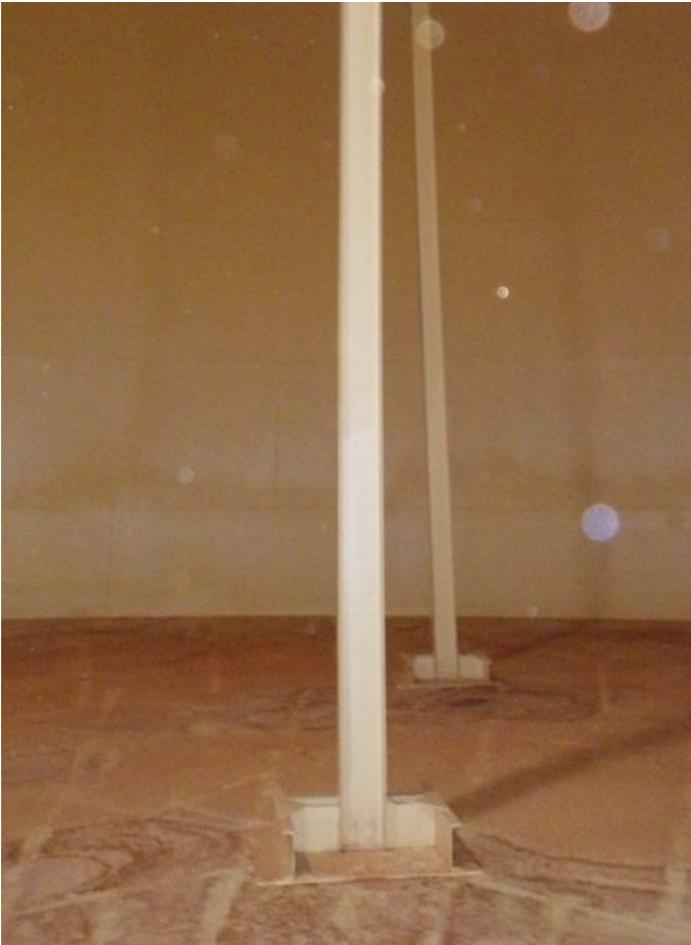
72. Columns.

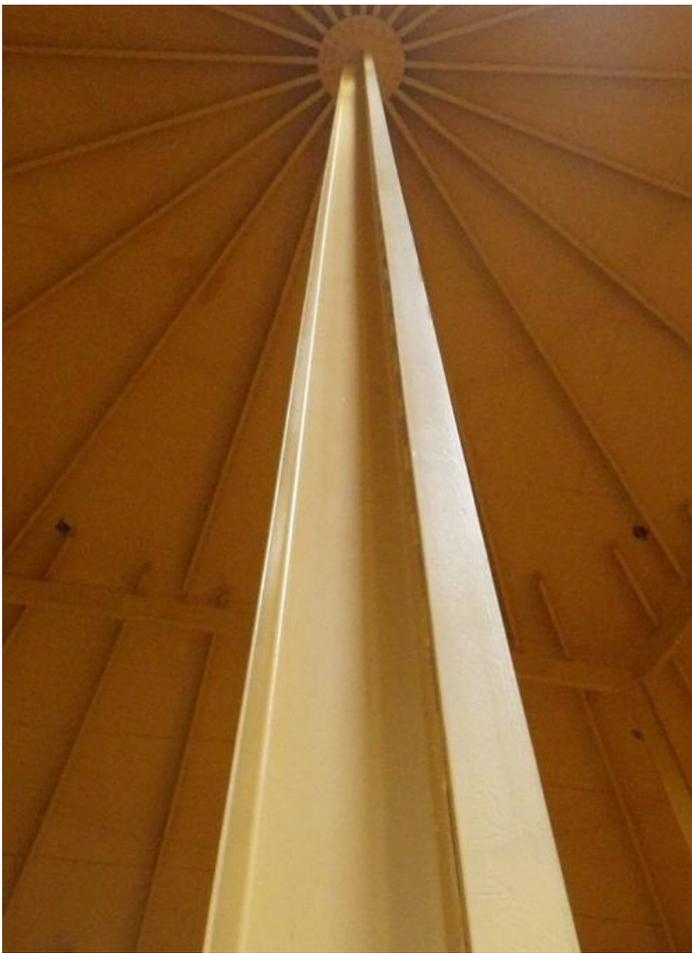
73. Roof support center column.

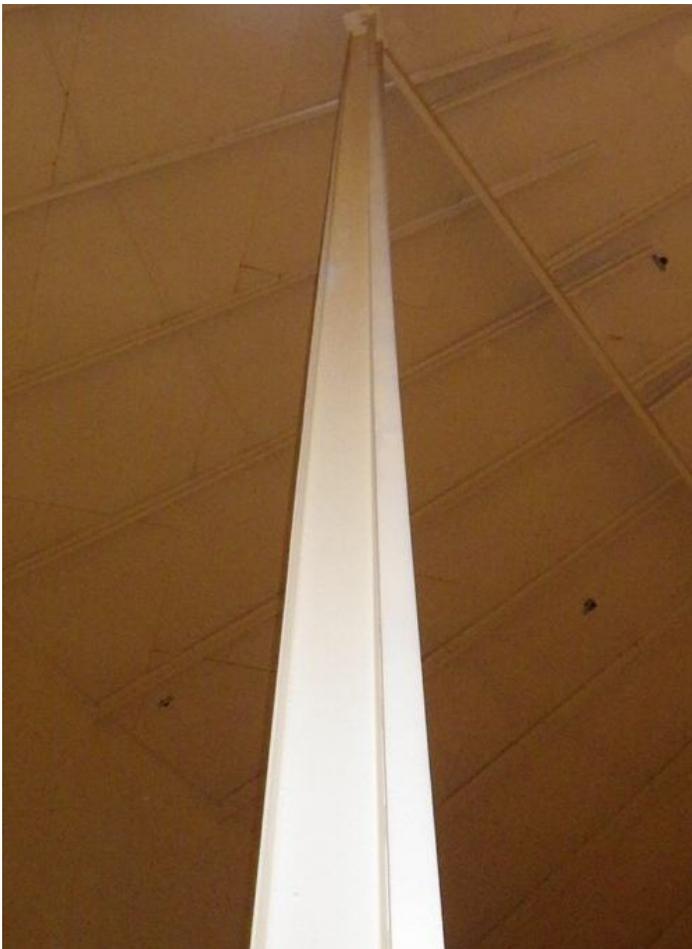
74. Roof support column.

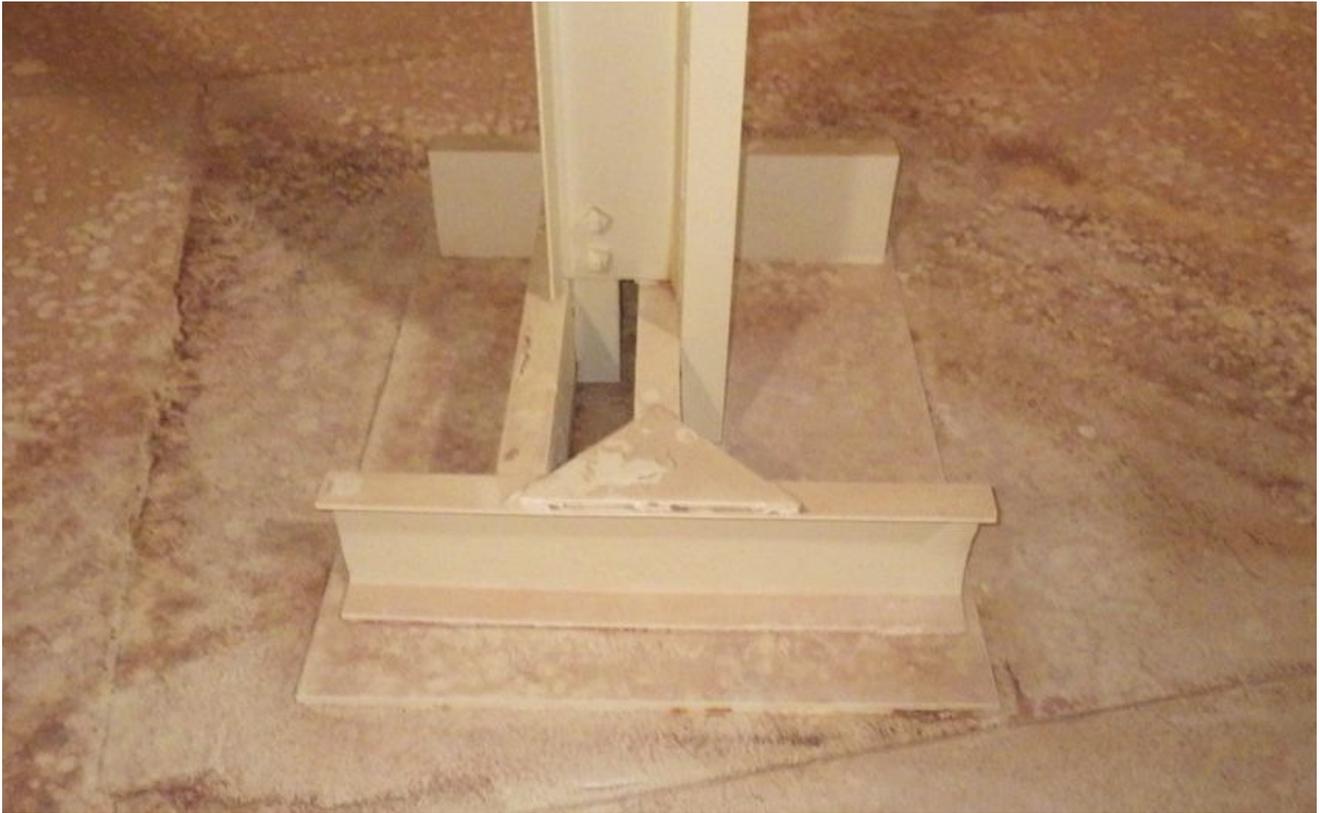
75. Roof support column base.

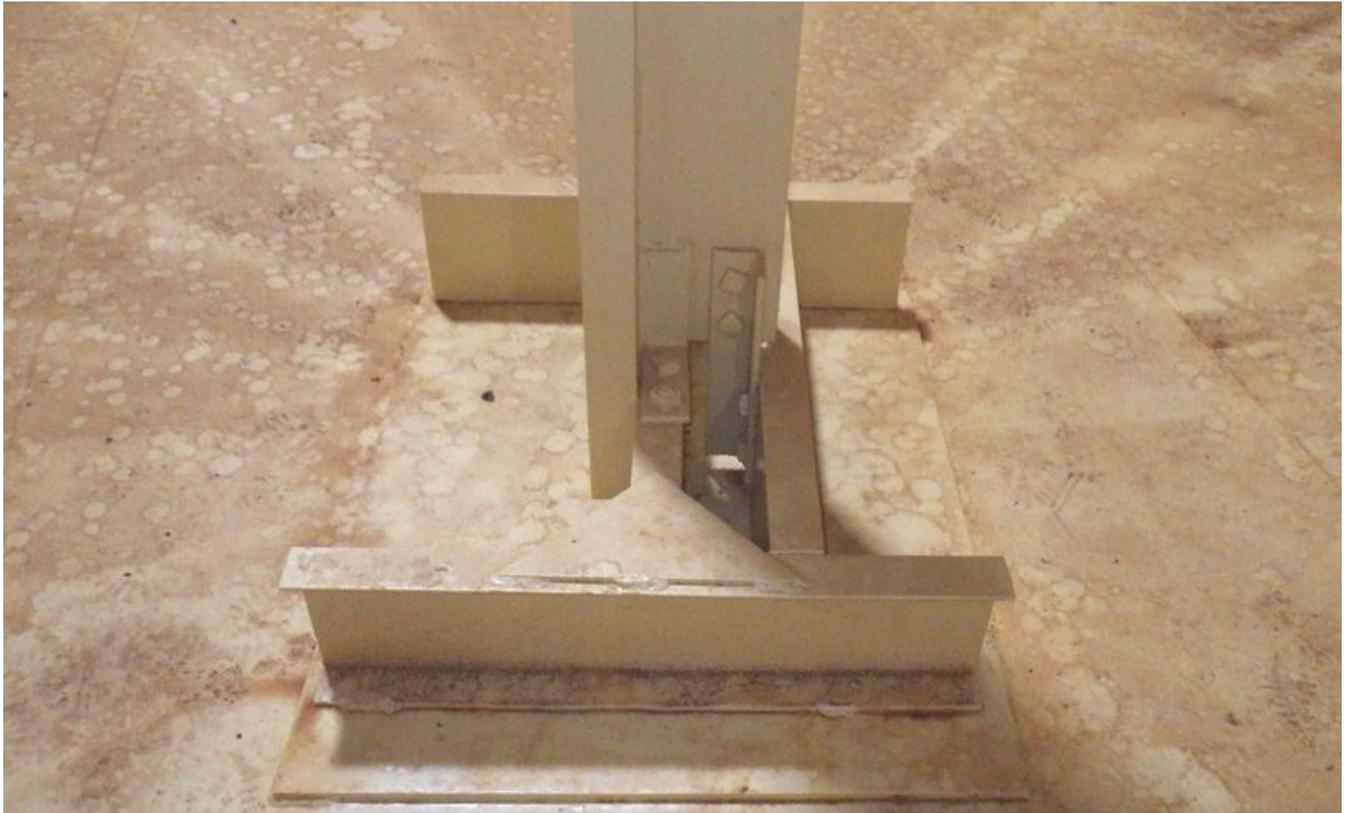
77. Roof support column base.

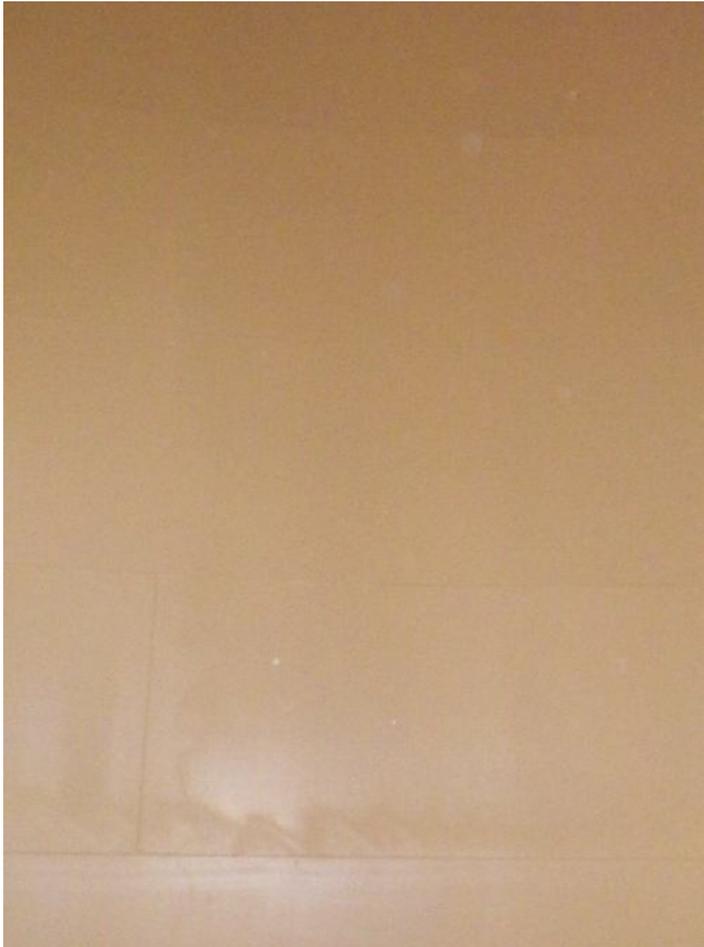
78. Interior shell.

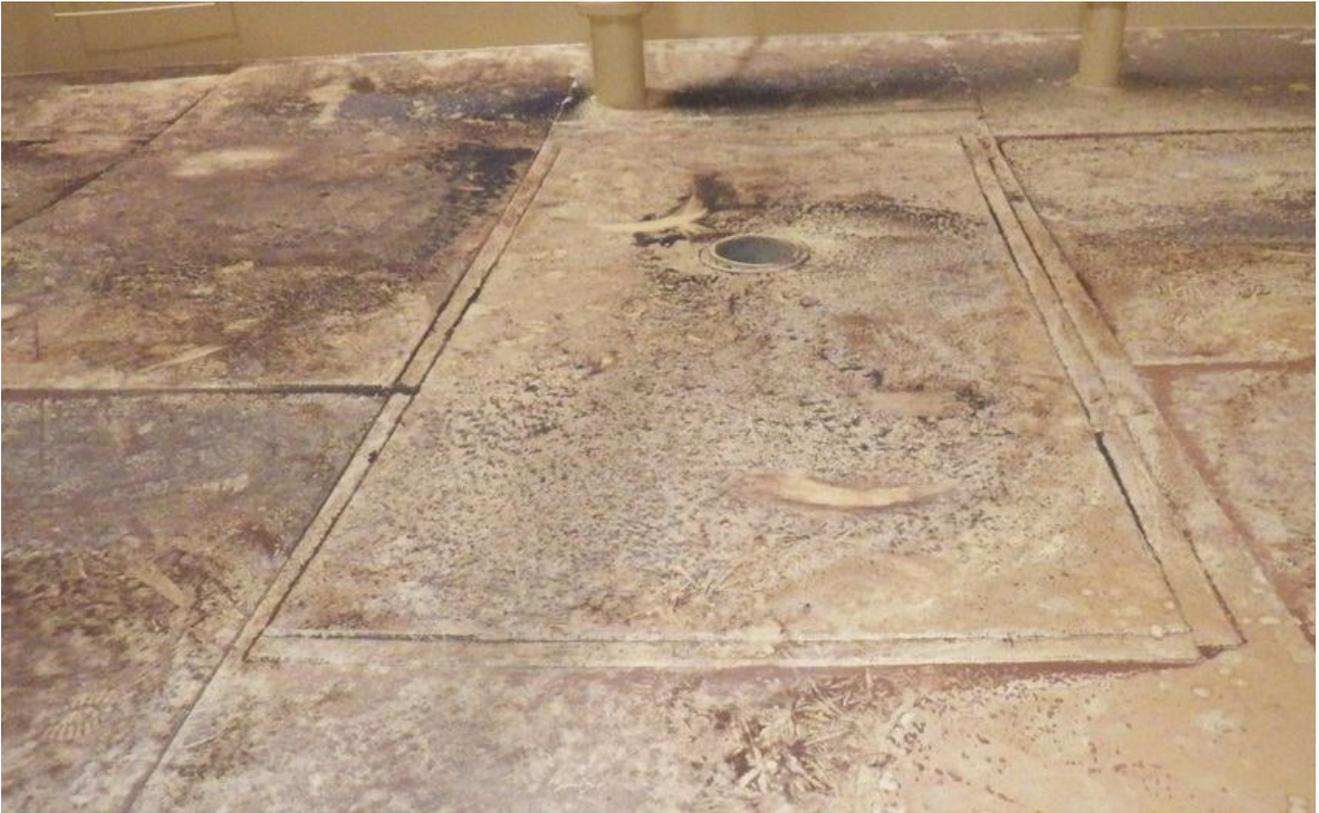
79. Floor opening. Note reinforcing floor plates.

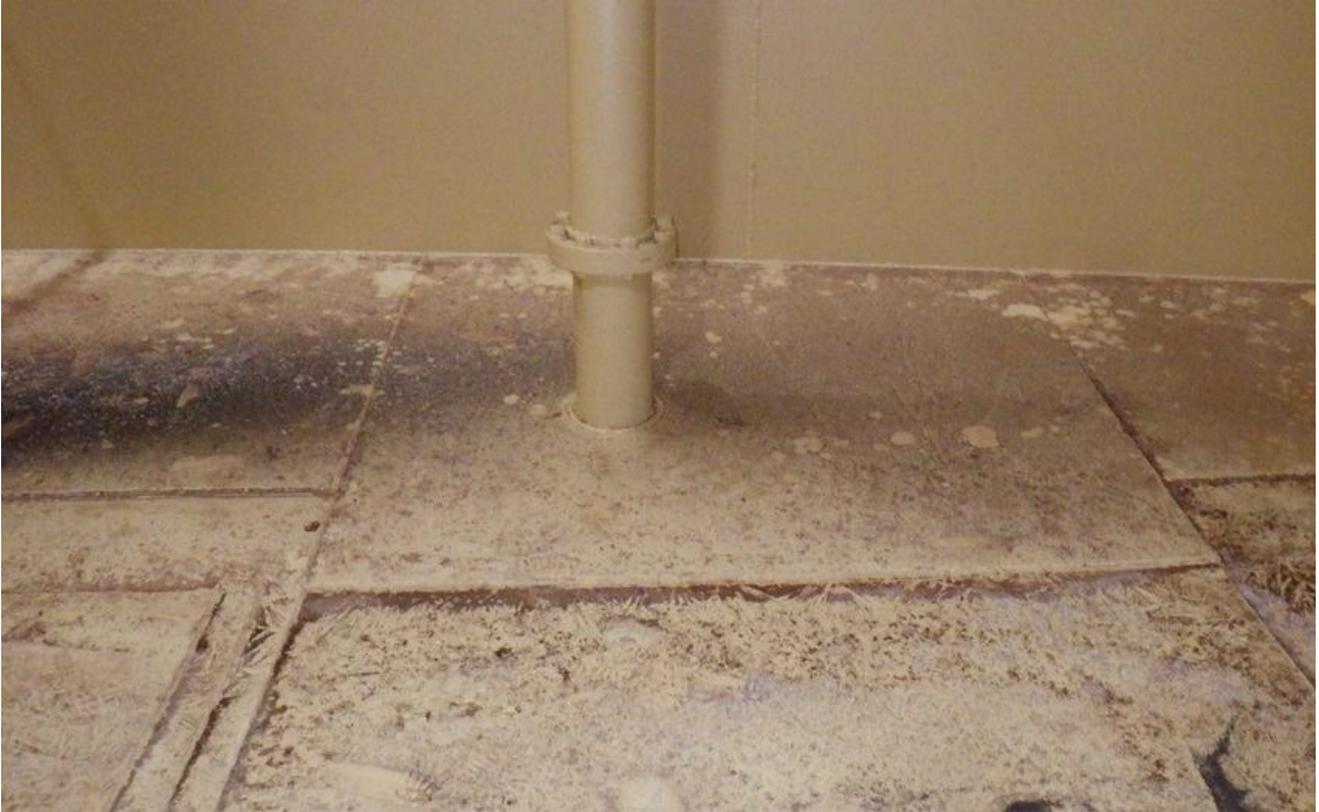
80. Overflow pipe floor penetration.

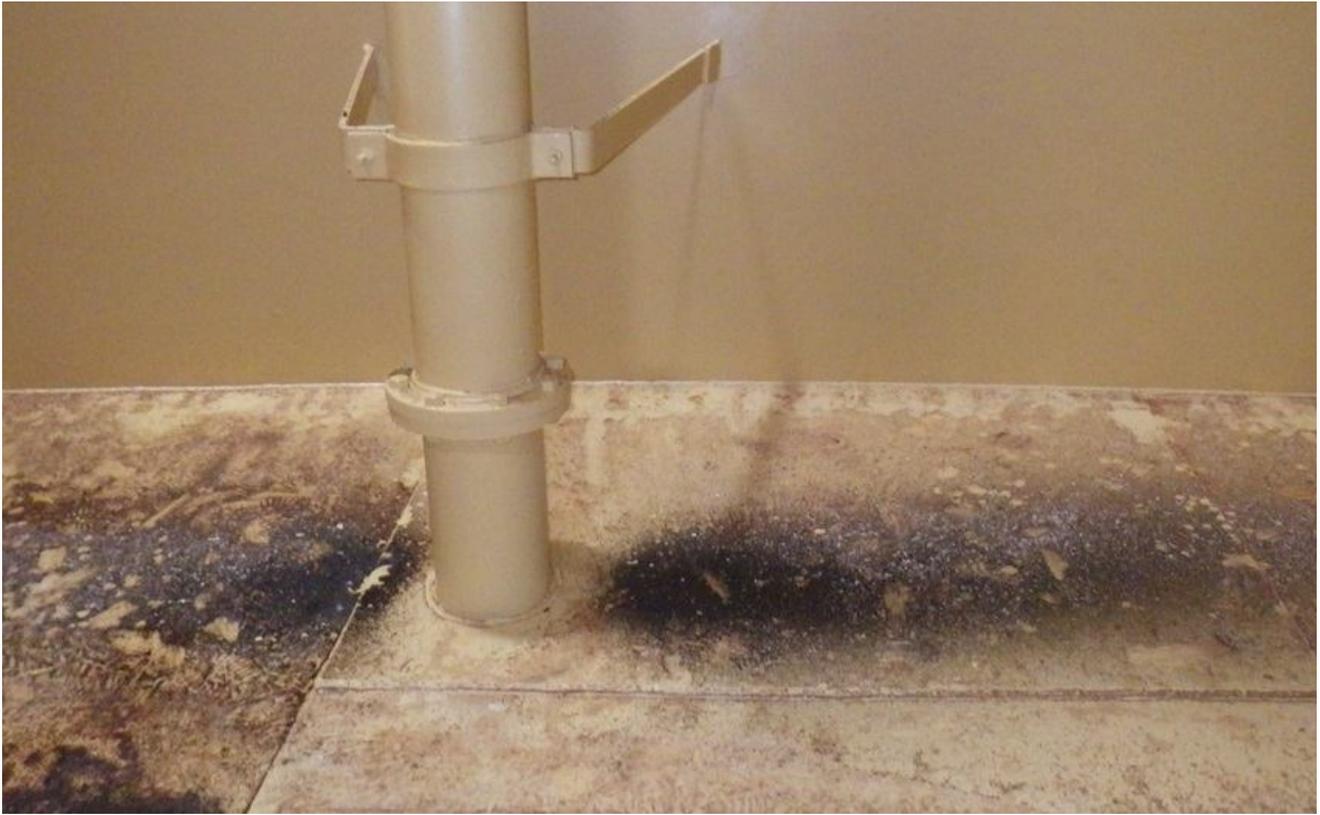
81. Inlet pipe floor penetration.

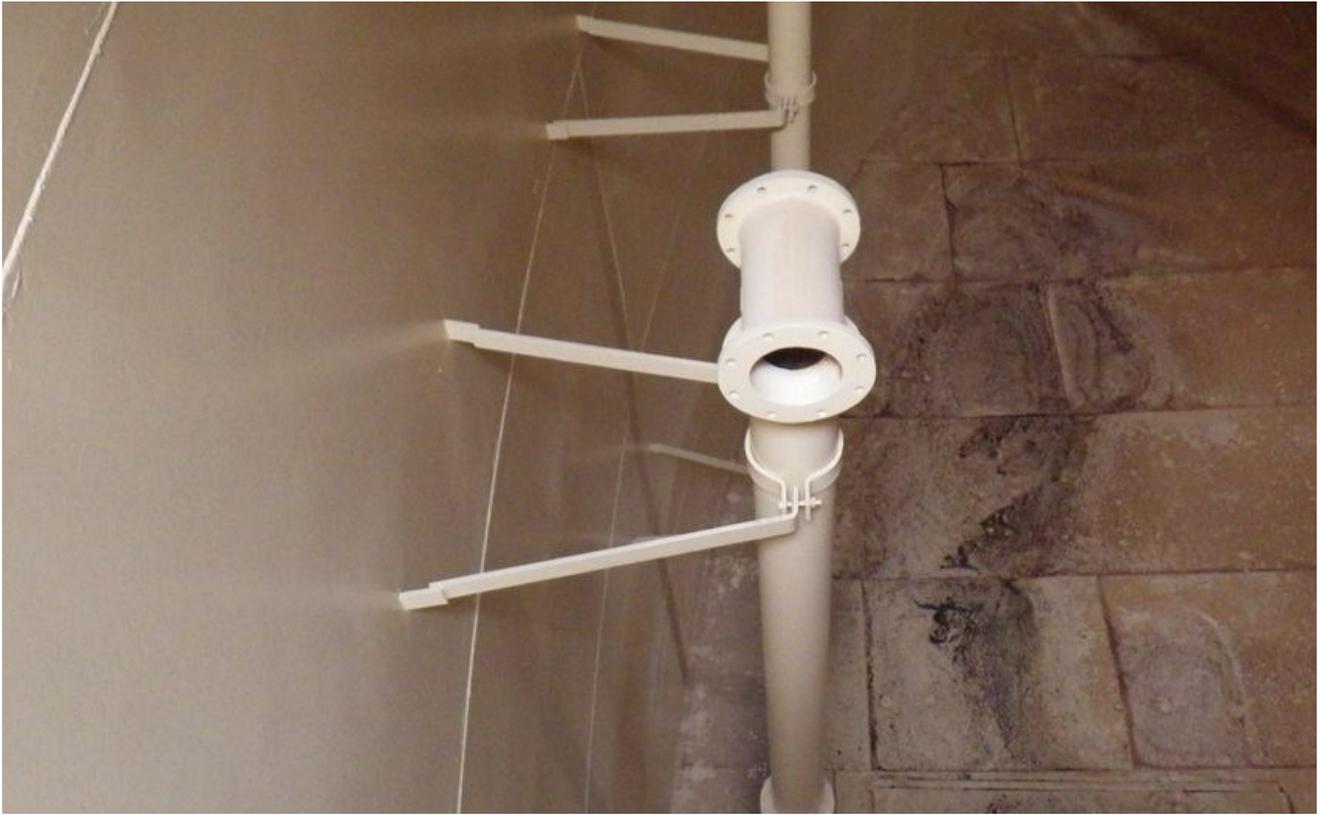
83. Inlet pipe discharge.

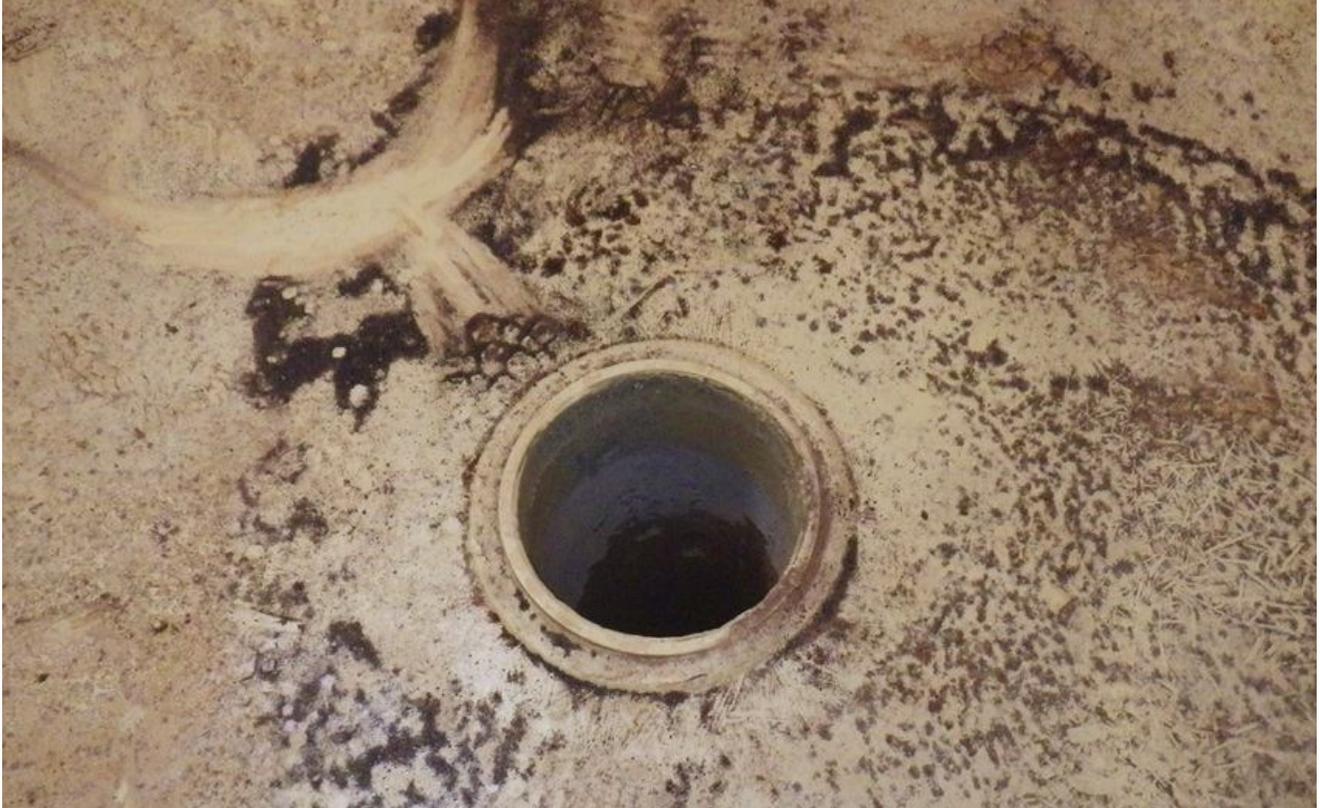
86. Outlet pipe opening.

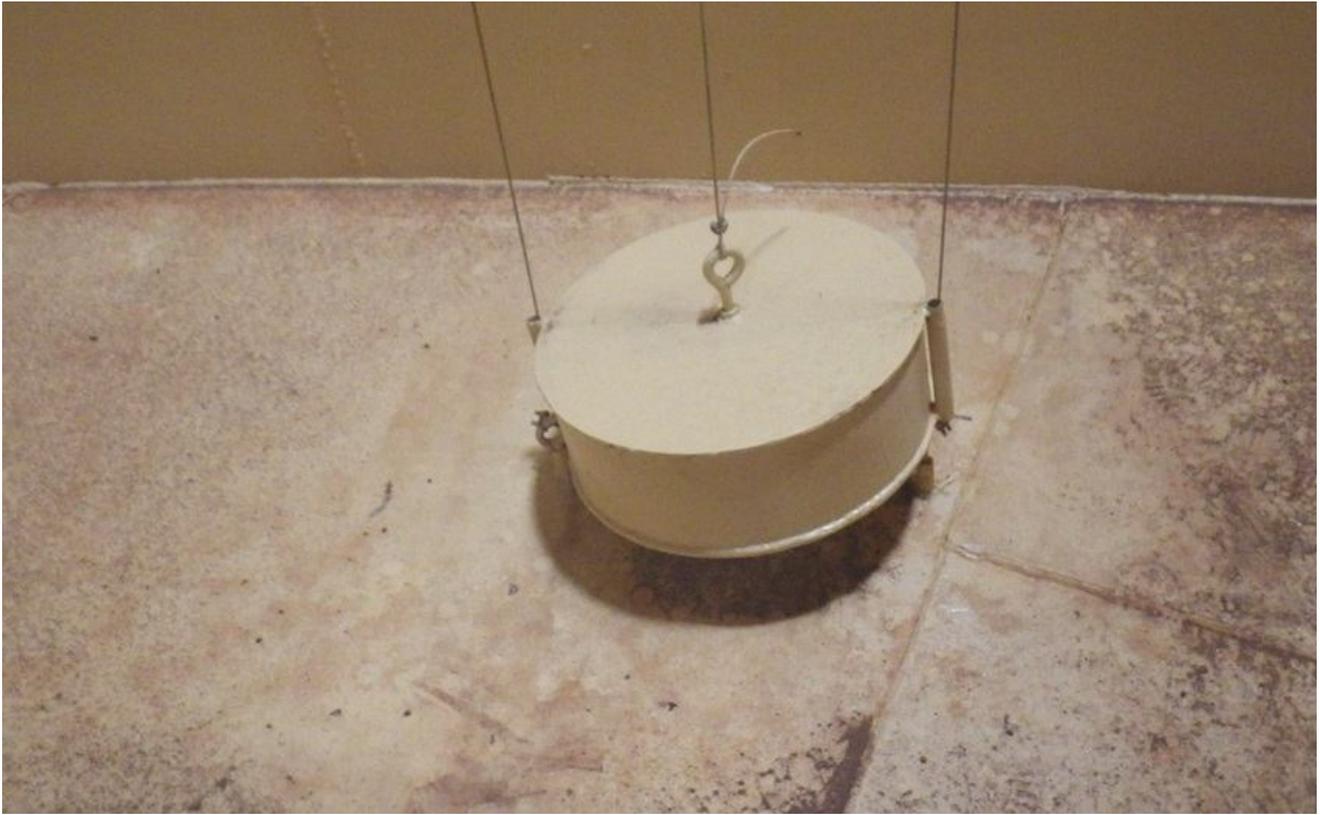
87. Target gage float.

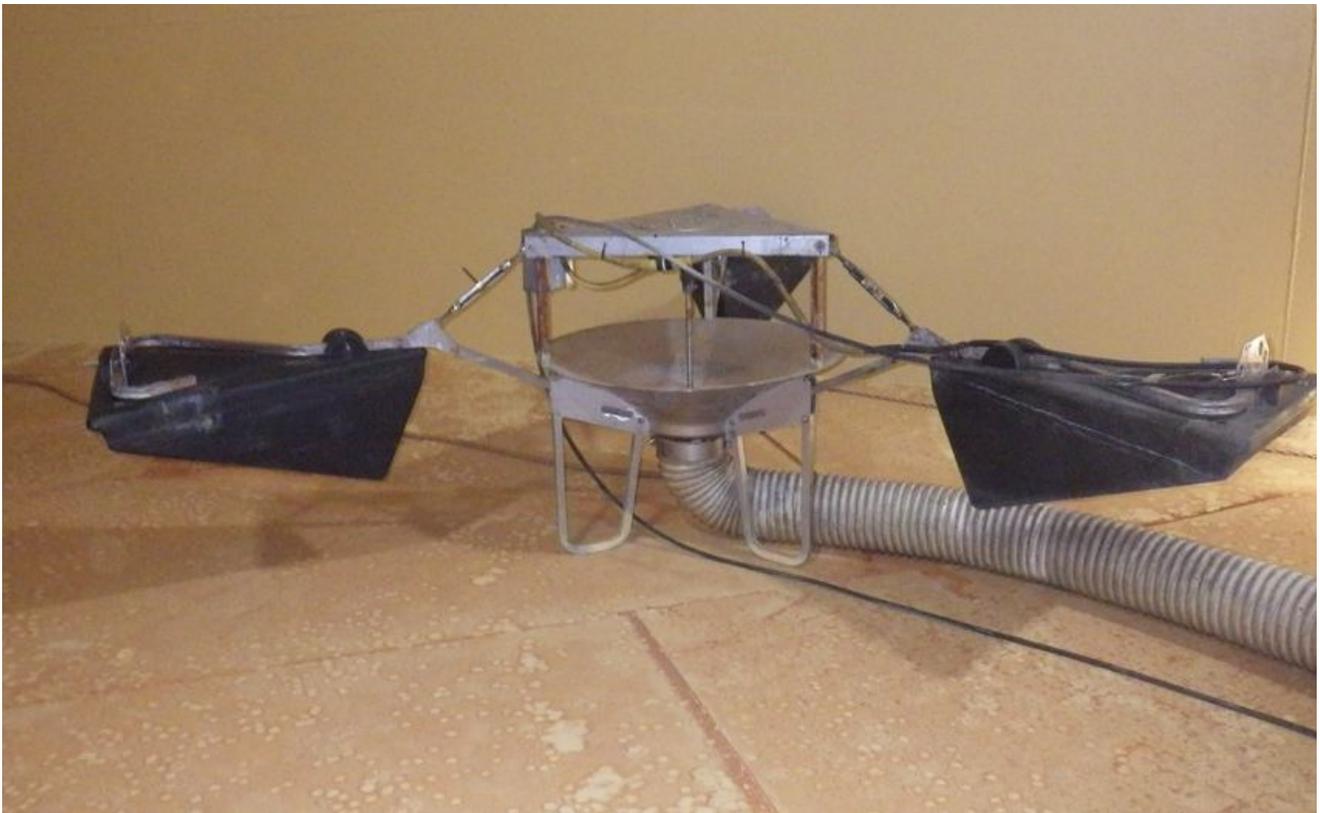
88. Water mixing system.
